HISTORIC STRUCTURE REPORT TRAVIS COUNTY PALM SCHOOL BUILDING

CONTRACT NO. 4400003304

APRIL 12, 2018

EXECUTIVE SUMMARY

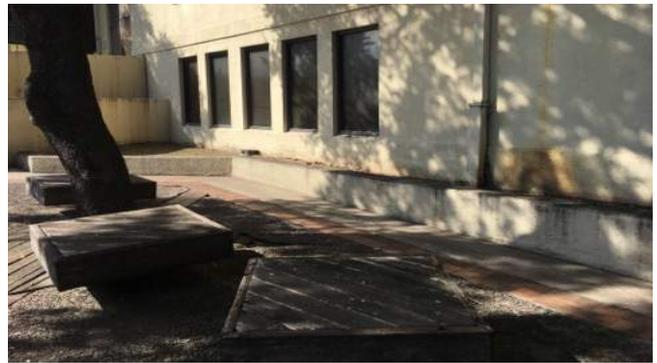
Empty planting bed and stained concrete wall within courtyard. Photo provided by DWG

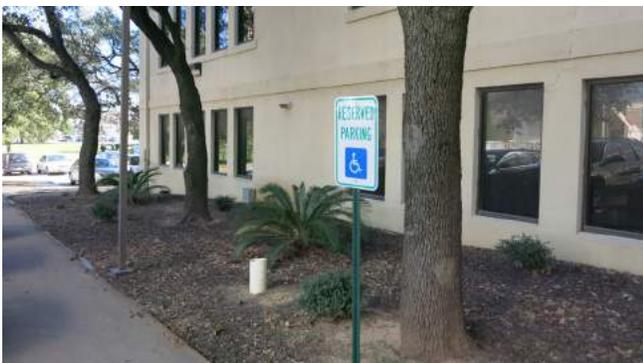
Bare planting bed on West side of northern most building. Photo provided by DWG

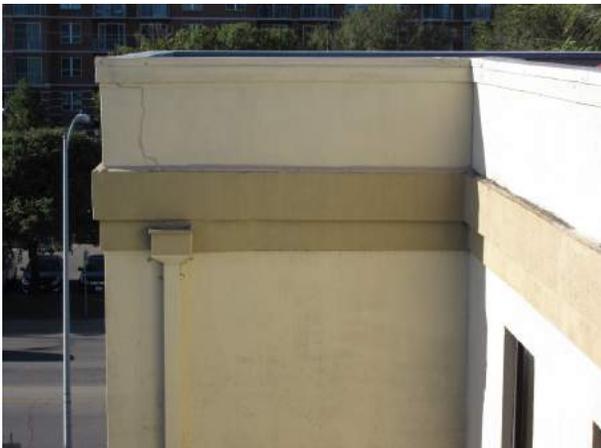
The stucco shows cracking and delamination in spot locations, The cracks in the parapet wall have been repaired with sealant, an inappropriate treatment.

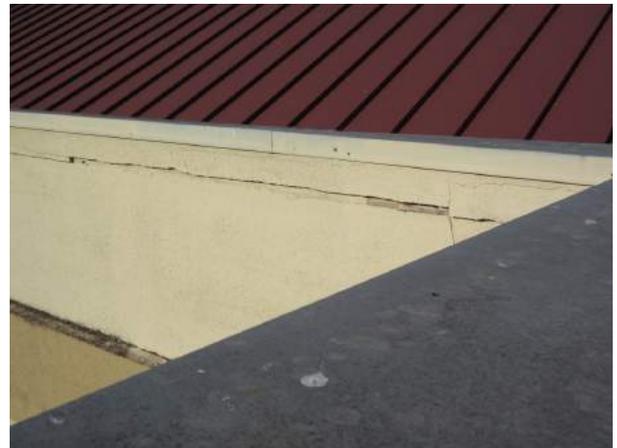
Some of the cracks in the stucco are large, and allow moisture to travel behind the stucco coating and to the masonry wall substrate.

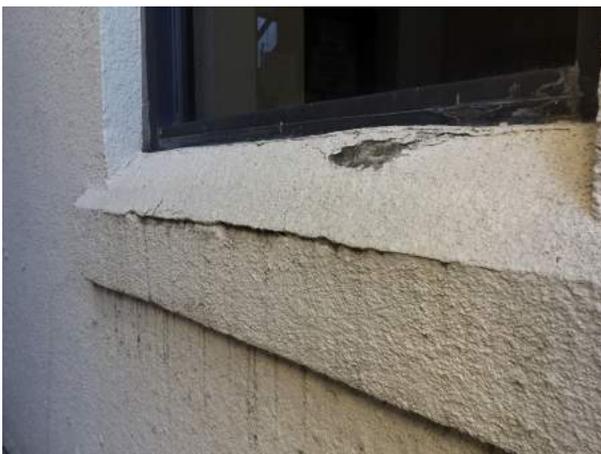
The stucco is cracked and deteriorated at projecting masonry window sills.

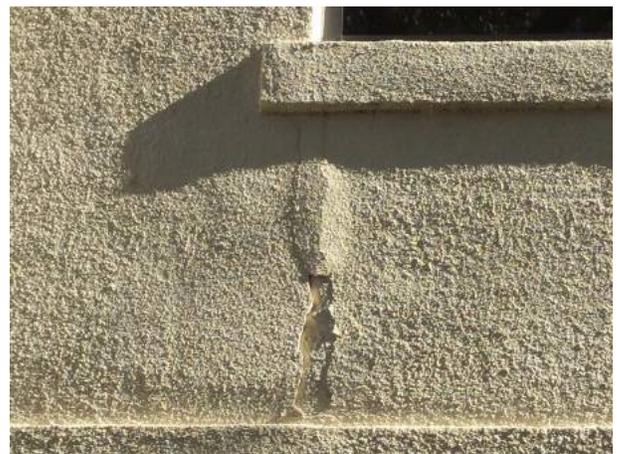
Vertical cracks in the stucco occur adjacent to the tall window openings in many locations.

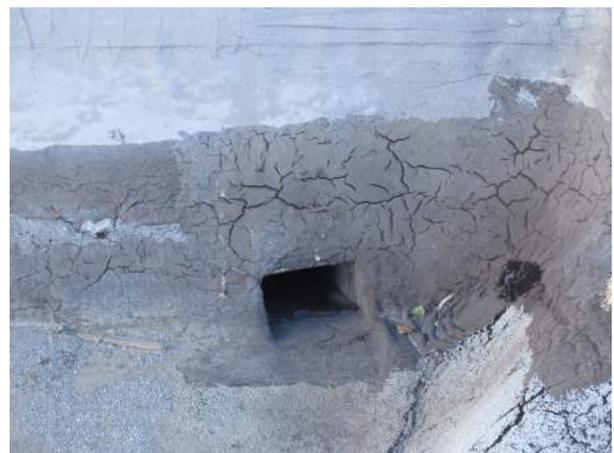
Small through-wall scuppers drain the roof surfaces to the downspouts. Note the cracked, brittle roofing mastic and the lack of overflow drainage.

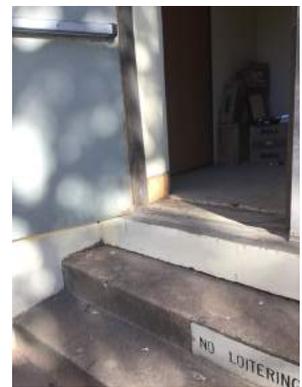
Lack of a Code compliant landing outside the Exit Discharge from the East Stair.

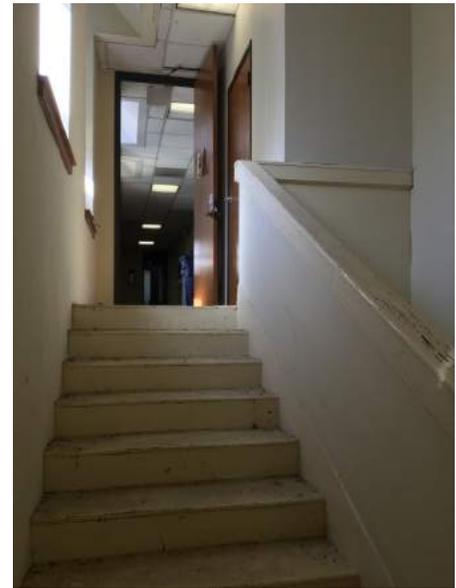
The third floor landing inside the East Stair shows a Storage enclosure opening inside the Egress Stairway Enclosure.

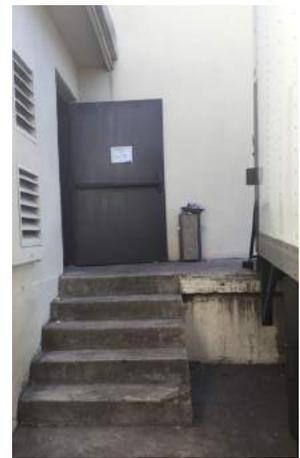
Exit Discharge at the 1949 Addition Loading Dock shows that steps are in need of repair and lack Code compliant handrails.

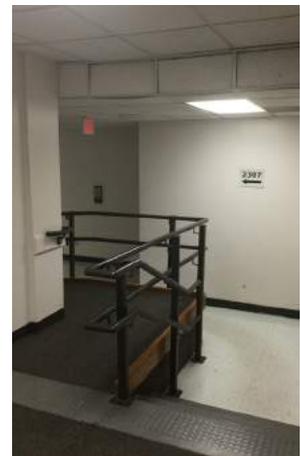
The ramp to the 1949 Addition lacks Code compliant headroom, slope, and landing size for a change in direction.

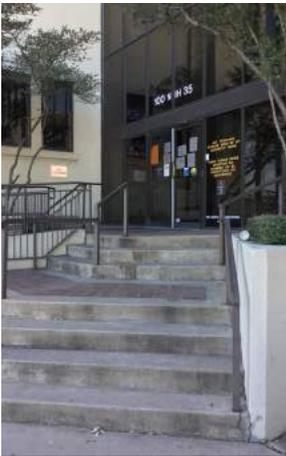
The handrails to the Main Entrance fail to meet the Code criteria for handrail graspability.
