Road Maintenance, Traffic Program
INTRA-DEPARTMENT MEMORANDUM

FY 2016 High Collision Locations Report

TNR Road Maintenance, Traffic Program

January 2016

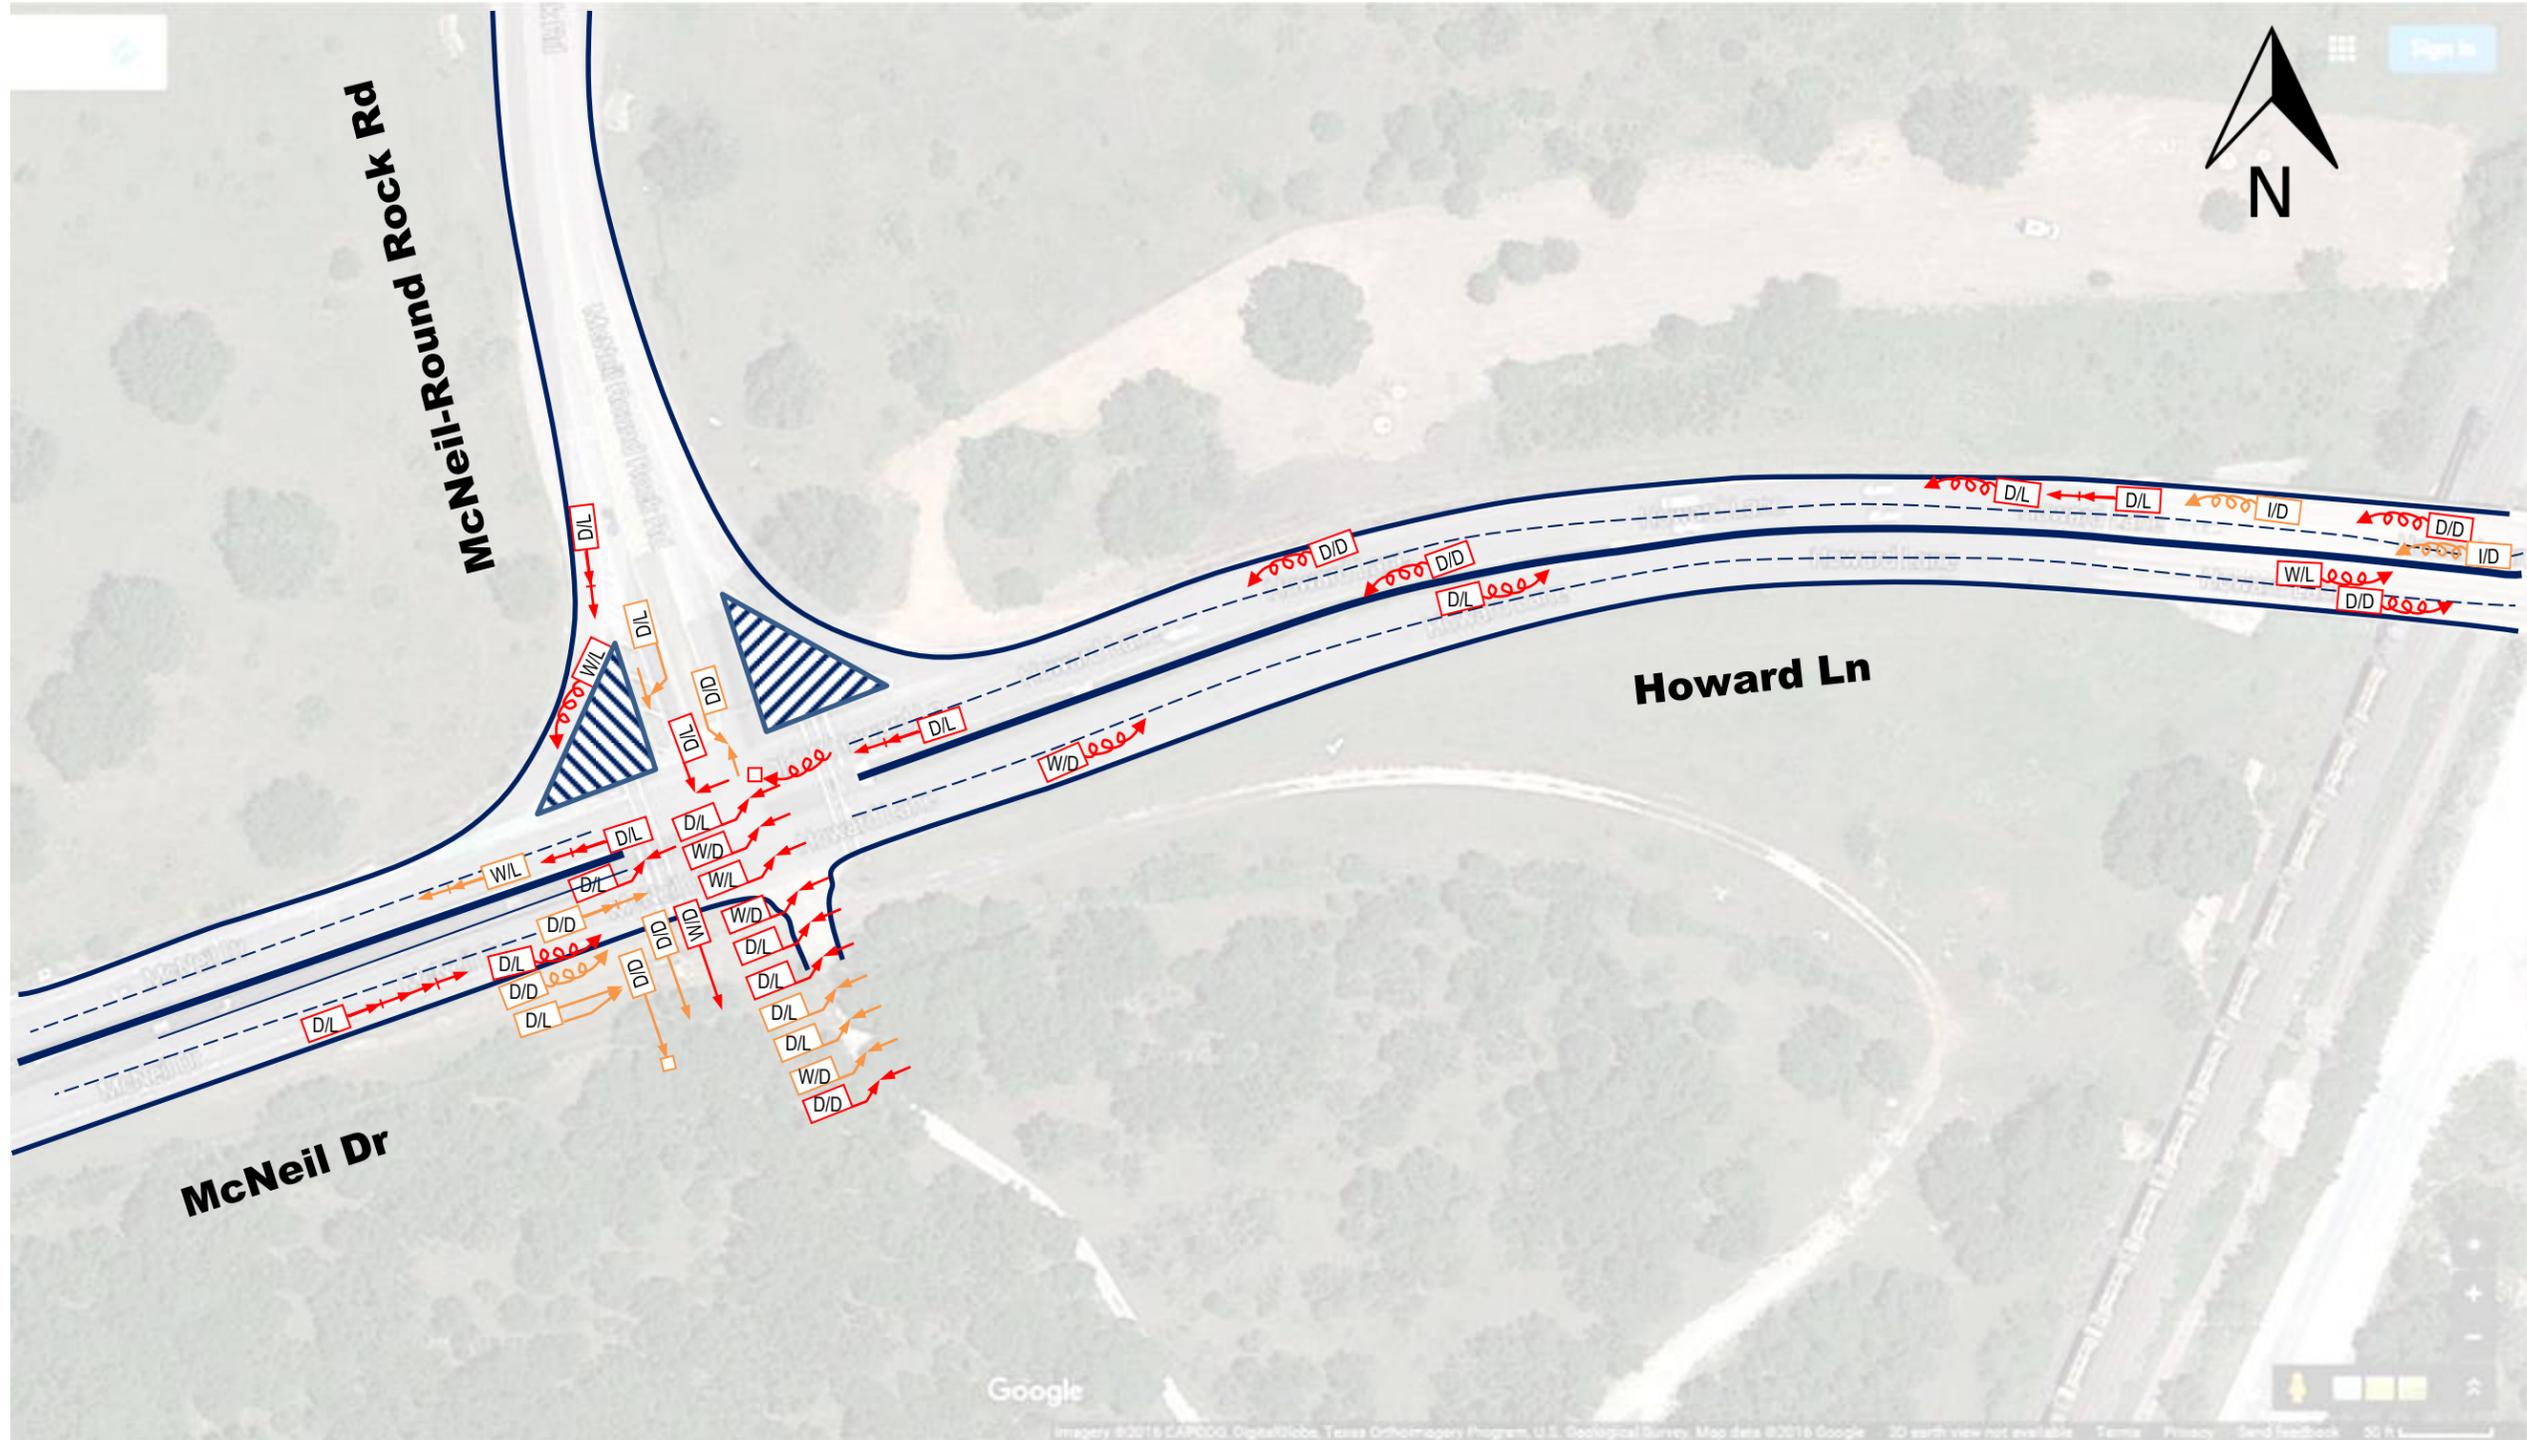
Howard Ln at McNeil-Round Rock Rd

FY	Crash ID	Crash Date YYYYMMDD	Crash Time 2400	Surface Conditions	Light Conditions	Weather Conditions	Block	Roadway	Intersection Reference	Location	Vehicles Involved	Accident Type	Injured	Contributing Factors	Comments
13	12968755	20121106	1715	1 = Dry	1 = Daylight	1 = Clear	5400	Howard Ln	McNeil Rd	200 FT E	2	Rear End	1	22 = Failed to Control Speed	WB
13	13047696	20121227	2335	2 = Wet	2 = Dark, Not Lighted	3 = Rain	13900	McNeil Rd	McNeil Dr	422 FT E	1	Out of Control	0	22 = Failed to Control Speed	EB, teen
13	13051523	20121228	1335	1 = Dry	1 = Daylight	1 = Clear	4300	Howard Ln	McNeil-Merrittown Rd	at	1	Out of Control	0	2 = Animal on Road - Wild	EB
13	13072639	20130104	1931	2 = Wet	3 = Dark, Lighted	3 = Rain	5400	Howard Ln	McNeil Rd	at	2	Left Turn	0	37 = Failed to Yield ROW – Turning Left	EB, Both YEL
13	13113357	20130205	2018	1 = Dry	2 = Dark, Not Lighted	1 = Clear	5400	Howard Ln	McNeil Rd	40 FT E	1	Out of Control	1	45 = Had Been Drinking	WB

13	13160347	20130308	1433	2 = Wet	1 = Daylight	2 = Cloudy	5700	McNeil Rd	McNeil Dr	10 FT N	1	Out of Control	0	60 = Unsafe Speed	SB
13	13183429	20130319	1210	1 = Dry	1 = Daylight	1 = Clear	5000	Howard Ln	McNeil Rd	at	2	Left Turn	3	37 = Failed to Yield ROW – Turning Left	EB, no protect?
13	13217801	20130413	1651	1 = Dry	1 = Daylight	1 = Clear	5400	Howard Ln	McNeil Rd	641 FT E	1	Out of Control	2	22 = Failed to Control Speed	EB, motorcycle
13	13223439	20130417	044	2 = Wet	3 = Dark, Lighted	3 = Rain	5400	Howard Ln	McNeil Dr	at	2	Left Turn	0	37 = Failed to Yield ROW – Turning Left	EB, YEL flash left
13	13268495	20130503	1111	1 = Dry	1 = Daylight	1 = Clear	4400	Howard Ln	McNeil Rd	at	2	Left Turn	1	20 = Driver Inattention	SB, permissive
13	13300879	20130503	1049	1 = Dry	1 = Daylight	1 = Clear	4400	Howard Ln	Merrittown Rd	20 FT W	2	Rear End	0	20 = Driver Inattention	WB, involved in previous
13	13302178	20130605	040	1 = Dry	2 = Dark, Not Lighted	1 = Clear	5400	Howard Ln	McNeil Rd	920 FT E	1	Out of Control	0	61 = Speeding – (Over Limit)	EB

14	13742475	20140316	2357	1 = Dry	2 = Dark, Not Lighted	1 = Clear	13700	McNeil Rd	Howard Ln	417 FT N	1	Out of Control	1	22 = Failed to Control Speed	WB
14	13792426	20140418	1500	1 = Dry	1 = Daylight	1 = Clear		Howard Ln	McNeil-Round Rock Rd	at	2	Left Turn	0	37 = Failed to Yield ROW – Turning Left	EB, permissive
14	13821122	20140507	546	1 = Dry	3 = Dark, Lighted	2 = Cloudy	5100	McNeil Dr	McNeil Rd	at	2	Left Turn	0	16 = Disregard Stop Sign or Light	SB, flash Y/R
14	13883754	20140615	332	1 = Dry	2 = Dark, Not Lighted	1 = Clear	5400	Howard Ln	McNeil Rd	at	1	Out of Control	0	19 = Distraction in Vehicle	SB
14	13893032	20140622	2215	1 = Dry	3 = Dark, Lighted	1 = Clear	5115	McNeil Dr	McNeil Rd	50 FT NE	1	Out of Control	0	45 = Had Been Drinking	SB
14	13895474	20140621	444	1 = Dry	3 = Dark, Lighted	1 = Clear	5400	Howard Ln	McNeil Rd	at	2	Rear End	1	67 = Under Influence – Alcohol	EB
14	13924840	20140714	539	1 = Dry	2 = Dark, Not Lighted	1 = Clear	5100	McNeil Dr	Howard Ln	50 FT W	1	Out of Control	1	98 = Other (Explain in Narrative)	EB, motorcycle

14	13918753	20140707	1420	1 = Dry	1 = Daylight	1 = Clear	5400	Howard Ln	McNeil Dr	at	2	Left Turn	2	37 = Failed to Yield ROW – Turning Left	EB, permissive
14	13935006	20140714	908	1 = Dry	1 = Daylight	1 = Clear	5400	Howard Ln	McNeil-Round Rock Rd	at	2	Left Turn	0	37 = Failed to Yield ROW – Turning Left	EB, permissive
15	14069082	20141015	1617	1 = Dry	1 = Daylight	1 = Clear	5400	Howard Ln	McNeil Rd	968 FT E	2	Rear End	3	22 = Failed to Control Speed	WB
15	14089498	20141023	1430	1 = Dry	1 = Daylight	1 = Clear	5100	McNeil Dr	McNeil Rd	at	2	Side Swipe	0	53 = Overtake and Pass Insufficient Clearance	SB
15	14237002	20150123	749	2 = Wet	1 = Daylight	3 = Rain	5100	McNeil Dr	McNeil Rd	100 FT W	2	Rear End	1	22 = Failed to Control Speed	WB
15	14255922	20150203	1801	2 = Wet	1 = Daylight	2 = Cloudy	5400	Howard Ln	McNeil Rd	916 FT E	1	Out of Control	0	60 = Unsafe Speed	EB
15	14308444	20150228	617	6 = Ice	2 = Dark, Not Lighted	4 = Sleet/Hail	5350	Howard Ln	McNeil Rd	925 FT E	1	Out of Control	0	41 = Faulty Evasive Action	WB

15	14309186	20150228	617	6 = Ice	2 = Dark, Not Lighted	4 = Sleet/Hail	5350	Howard Ln	McNeil Rd	965 FT E	1	Out of Control	0	22 = Failed to Control Speed	WB
15	14487785	20150529	741	1 = Dry	1 = Daylight	1 = Clear	5444	Howard Ln	McNeil Rd	at	2	Left Turn	0	16 = Disregard Stop Sign or Light	WB, flash
15	14392452	20150414	1715	1 = Dry	1 = Daylight	1 = Clear	5100	McNeil Dr	McNeil Rd	at	2	Side Swipe	0	20 = Driver Inattention	EB
15	14450064	20150523	2300	2 = Wet	3 = Dark, Lighted	3 = Rain	5100	McNeil Dr	McNeil Rd	at	2	Left Turn	1	98 = Other (Explain in Narrative)	EB, fail stop
15	14501269	20150605	2310	1 = Dry	3 = Dark, Lighted	1 = Clear	5100	McNeil Dr	McNeil Rd	at	2	Left Turn	2	66 = Turned when Unsafe	EB, permissive

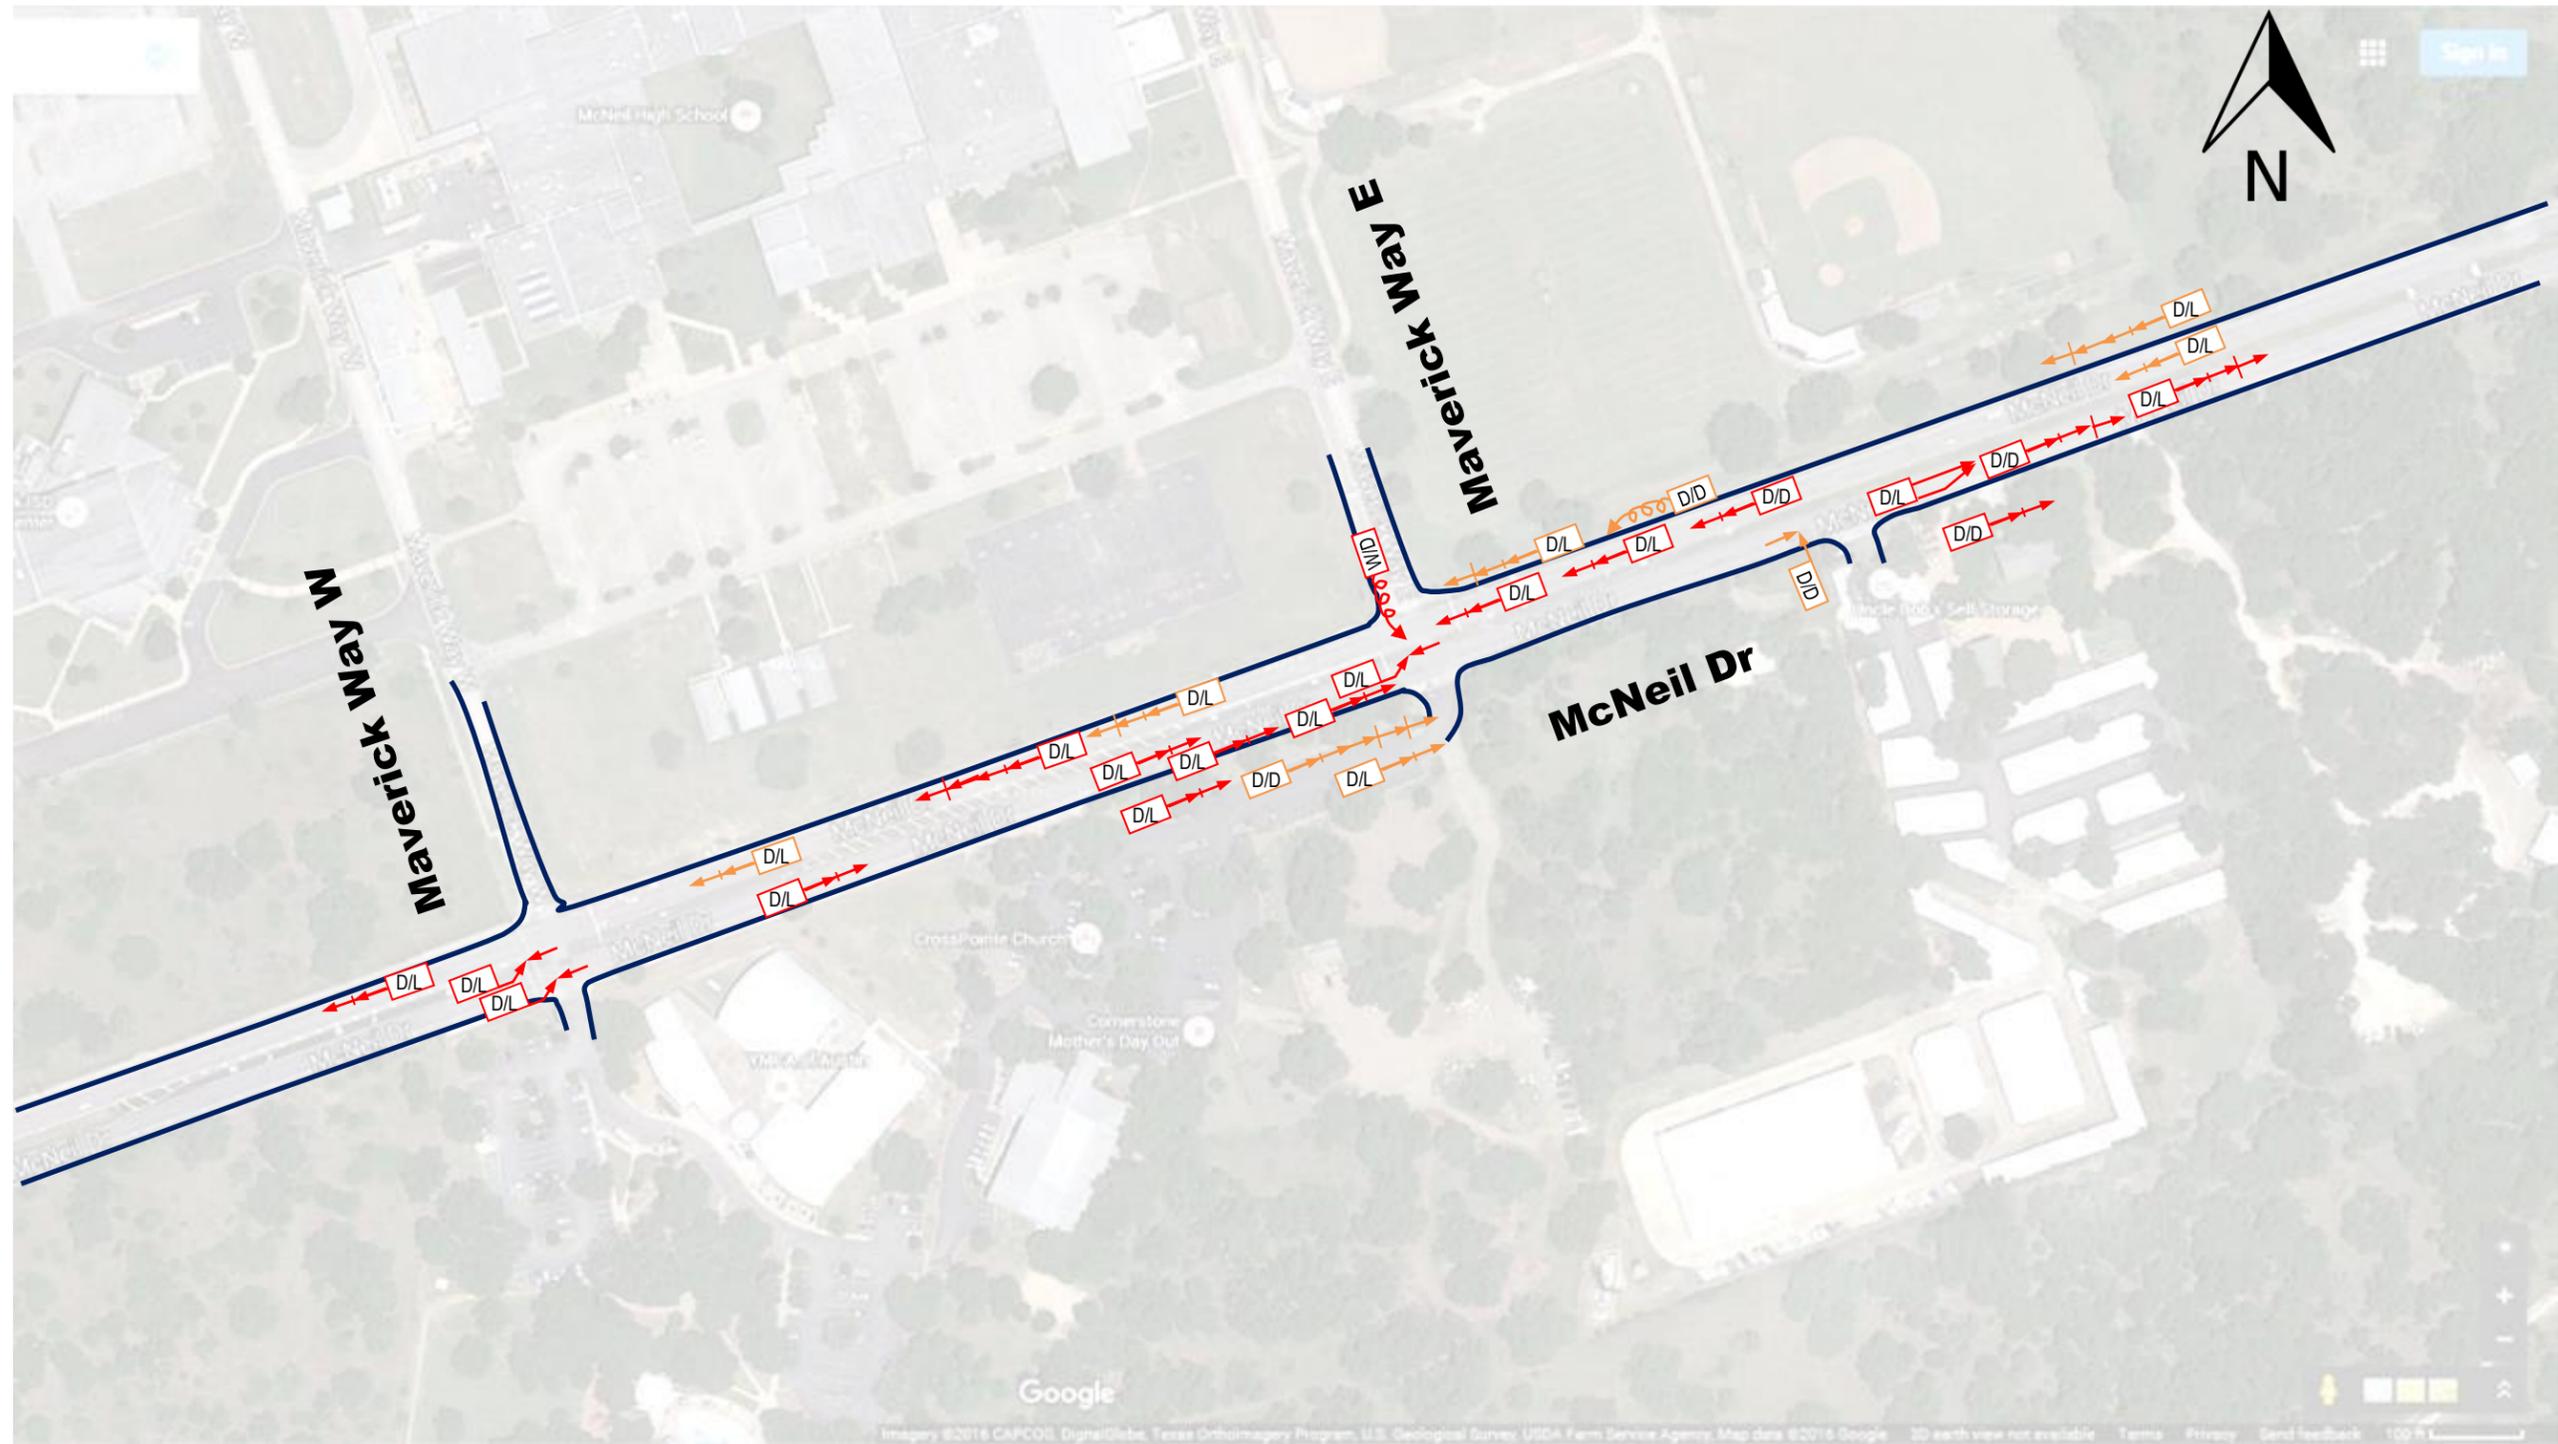
McNeil Dr at McNeil High School

FY	Crash ID	Crash Date YYYYMMDD	Crash Time 2400	Surface Conditions	Light Conditions	Weather Conditions	Block	Roadway	Intersection Reference	Location	Vehicles Involved	Accident Type	Injured	Contributing Factors	Comments
13	12942211	20121022	1210	1 = Dry	1 = Daylight	1 = Clear	5700	McNeil Dr	McNeil-Round Rock Rd	20 FT SW	2	Rear End	1	22 = Failed to Control Speed	EB
13	12978859	20121112	1725	1 = Dry	1 = Daylight	1 = Clear	5500	McNeil Dr	McNeil Rd	910 FT W	3	Rear End	0	22 = Failed to Control Speed	WB
13	13143848	20130226	1634	1 = Dry	1 = Daylight	1 = Clear	5700	McNeil Rd	Parmer Ln	0.6 mi E	4	Rear End	1	22 = Failed to Control Speed	WB
13	13261723	20130510	1625	1 = Dry	1 = Daylight	1 = Clear	5700	McNeil Dr	McNeil	0.75 mi SW	2	Rear End	1	20 = Driver Inattention	WB
13	13306352	20130606	1430	1 = Dry	1 = Daylight	1 = Clear	5500	McNeil Dr	McNeil Rd	0.2 mi W	2	Side Swipe	1	4 = Changed Lane when Unsafe	EB
13	13412927	20130819	243	1 = Dry	2 = Dark, Not Lighted	1 = Clear	5700	McNeil Dr	McNeil Rd	0.4 mi W	2	Rear End	1	45 = Had Been Drinking	WB

13	13475775	20130926	1656	1 = Dry	1 = Daylight	1 = Clear	5720	McNeil Rd	Howard Ln	0.5 mi E	2	Rear End	0	41 = Faulty Evasive Action	WB, school bus
14	13487040	20131010	837	1 = Dry	1 = Daylight	2 = Cloudy	5800	McNeil Rd	734	0.08 mi E	2	Left Turn	0	33 = Failed to Yield ROW – Open Intersection	EB, ymca
14	13562411	20131116	022	1 = Dry	2 = Dark, Not Lighted	1 = Clear	5500	McNeil Dr	McNeil Rd	713 FT W	2	Rear End	2	67 = Under Influence – Alcohol	EB
14	13714937	20140303	824	1 = Dry	1 = Daylight	1 = Clear	5800	McNeil Dr	Maverick Way	at	2	Left Turn	0	37 = Failed to Yield ROW – Turning Left	EB, teen
14	13727748	20140305	1810	1 = Dry	1 = Daylight	1 = Clear	5700	McNeil Dr	McNeil Rd	0.25 mi S	2	Rear End	0	22 = Failed to Control Speed	EB, teen
14	13820361	20140502	1445	1 = Dry	1 = Daylight	1 = Clear		McNeil Dr	Maverick Way	at	2	Left Turn	3	37 = Failed to Yield ROW – Turning Left	EB, teen
14	13837110	20150516	910	1 = Dry	1 = Daylight	1 = Clear	5700	McNeil Rd	Parmer Ln	400 FT E	2	Rear End	0	22 = Failed to Control Speed	EB, teens

14	13841078	20140519	1613	1 = Dry	1 = Daylight	1 = Clear	5500	McNeil Dr	McNeil Rd	0.37 mi SW	3	Rear End	1	22 = Failed to Control Speed	EB, teens
14	13883563	20140607	2100	1 = Dry	2 = Dark, Not Lighted	1 = Clear	5720	McNeil Dr	McNeil Rd	0.39 mi W	5	Rear End	1	60 = Unsafe Speed	EB
14	13965630	20140811	100	1 = Dry	2 = Dark, Not Lighted	1 = Clear	5700	McNeil Rd	Parmer Ln	0.3 mi E	1	Out of Control	0	45 = Had Been Drinking	WB
14	13977596	20140709	907	1 = Dry	1 = Daylight	1 = Clear	5500	McNeil Dr	McNeil Rd	850 FT W	2	Rear End	0	22 = Failed to Control Speed	WB, teens
14	13999213	20140902	1646	1 = Dry	1 = Daylight	1 = Clear	5800	McNeil Dr	Parmer Ln	0.69 mi E	2	Rear End	1	22 = Failed to Control Speed	WB
14	14042768	20140929	1714	1 = Dry	1 = Daylight	1 = Clear	5800	McNeil Dr	Parmer Ln	1000 FT E	2	Rear End	1	22 = Failed to Control Speed	EB, teens
14	14045171	20140930	1820	1 = Dry	1 = Daylight	1 = Clear	5700	McNeil Dr	McNeil Rd	1000 FT E	2	Rear End	0	22 = Failed to Control Speed	EB

15	14054199	20141007	645	1 = Dry	2 = Dark, Not Lighted	1 = Clear	5541	McNeil Dr	McNeil Rd	0.5 mi W	2	Right Angle	0	34 = Failed to Yield ROW – Private Drive	EB
15	14215923	20150109	1444	1 = Dry	1 = Daylight	2 = Cloudy	5700	McNeil Dr	McNeil Rd	0.25 mi W	3	Rear End	0	22 = Failed to Control Speed	WB
15	14245638	20150128	1748	1 = Dry	1 = Daylight	1 = Clear	5500	McNeil Dr	McNeil Rd	751 FT W	3	Rear End	0	48 = Impaired Visibility (Explain in Narrative)	WB
15	14316236	20150304	1752	2 = Wet	6 = Dusk	3 = Rain	5720	McNeil Dr	McNeil Dr	0.5 mi E	1	Out of Control	0	20 = Driver Inattention	SB, teen
15	14344866	20150326	920	1 = Dry	1 = Daylight	2 = Cloudy	5700	McNeil Rd	McNeil-Round Rock Rd	0.1 mi W	2	Rear End	0	22 = Failed to Control Speed	EB
15	14486432	20150501	813	1 = Dry	1 = Daylight	1 = Clear	5500	McNeil Dr	McNeil Rd	1000 FT W	4	Rear End	0	20 = Driver Inattention	WB
15	14497352	20150603	1330	1 = Dry	1 = Daylight	1 = Clear	5800	McNeil Dr	734	800 FT E	2	Rear End	0	22 = Failed to Control Speed	WB, teen

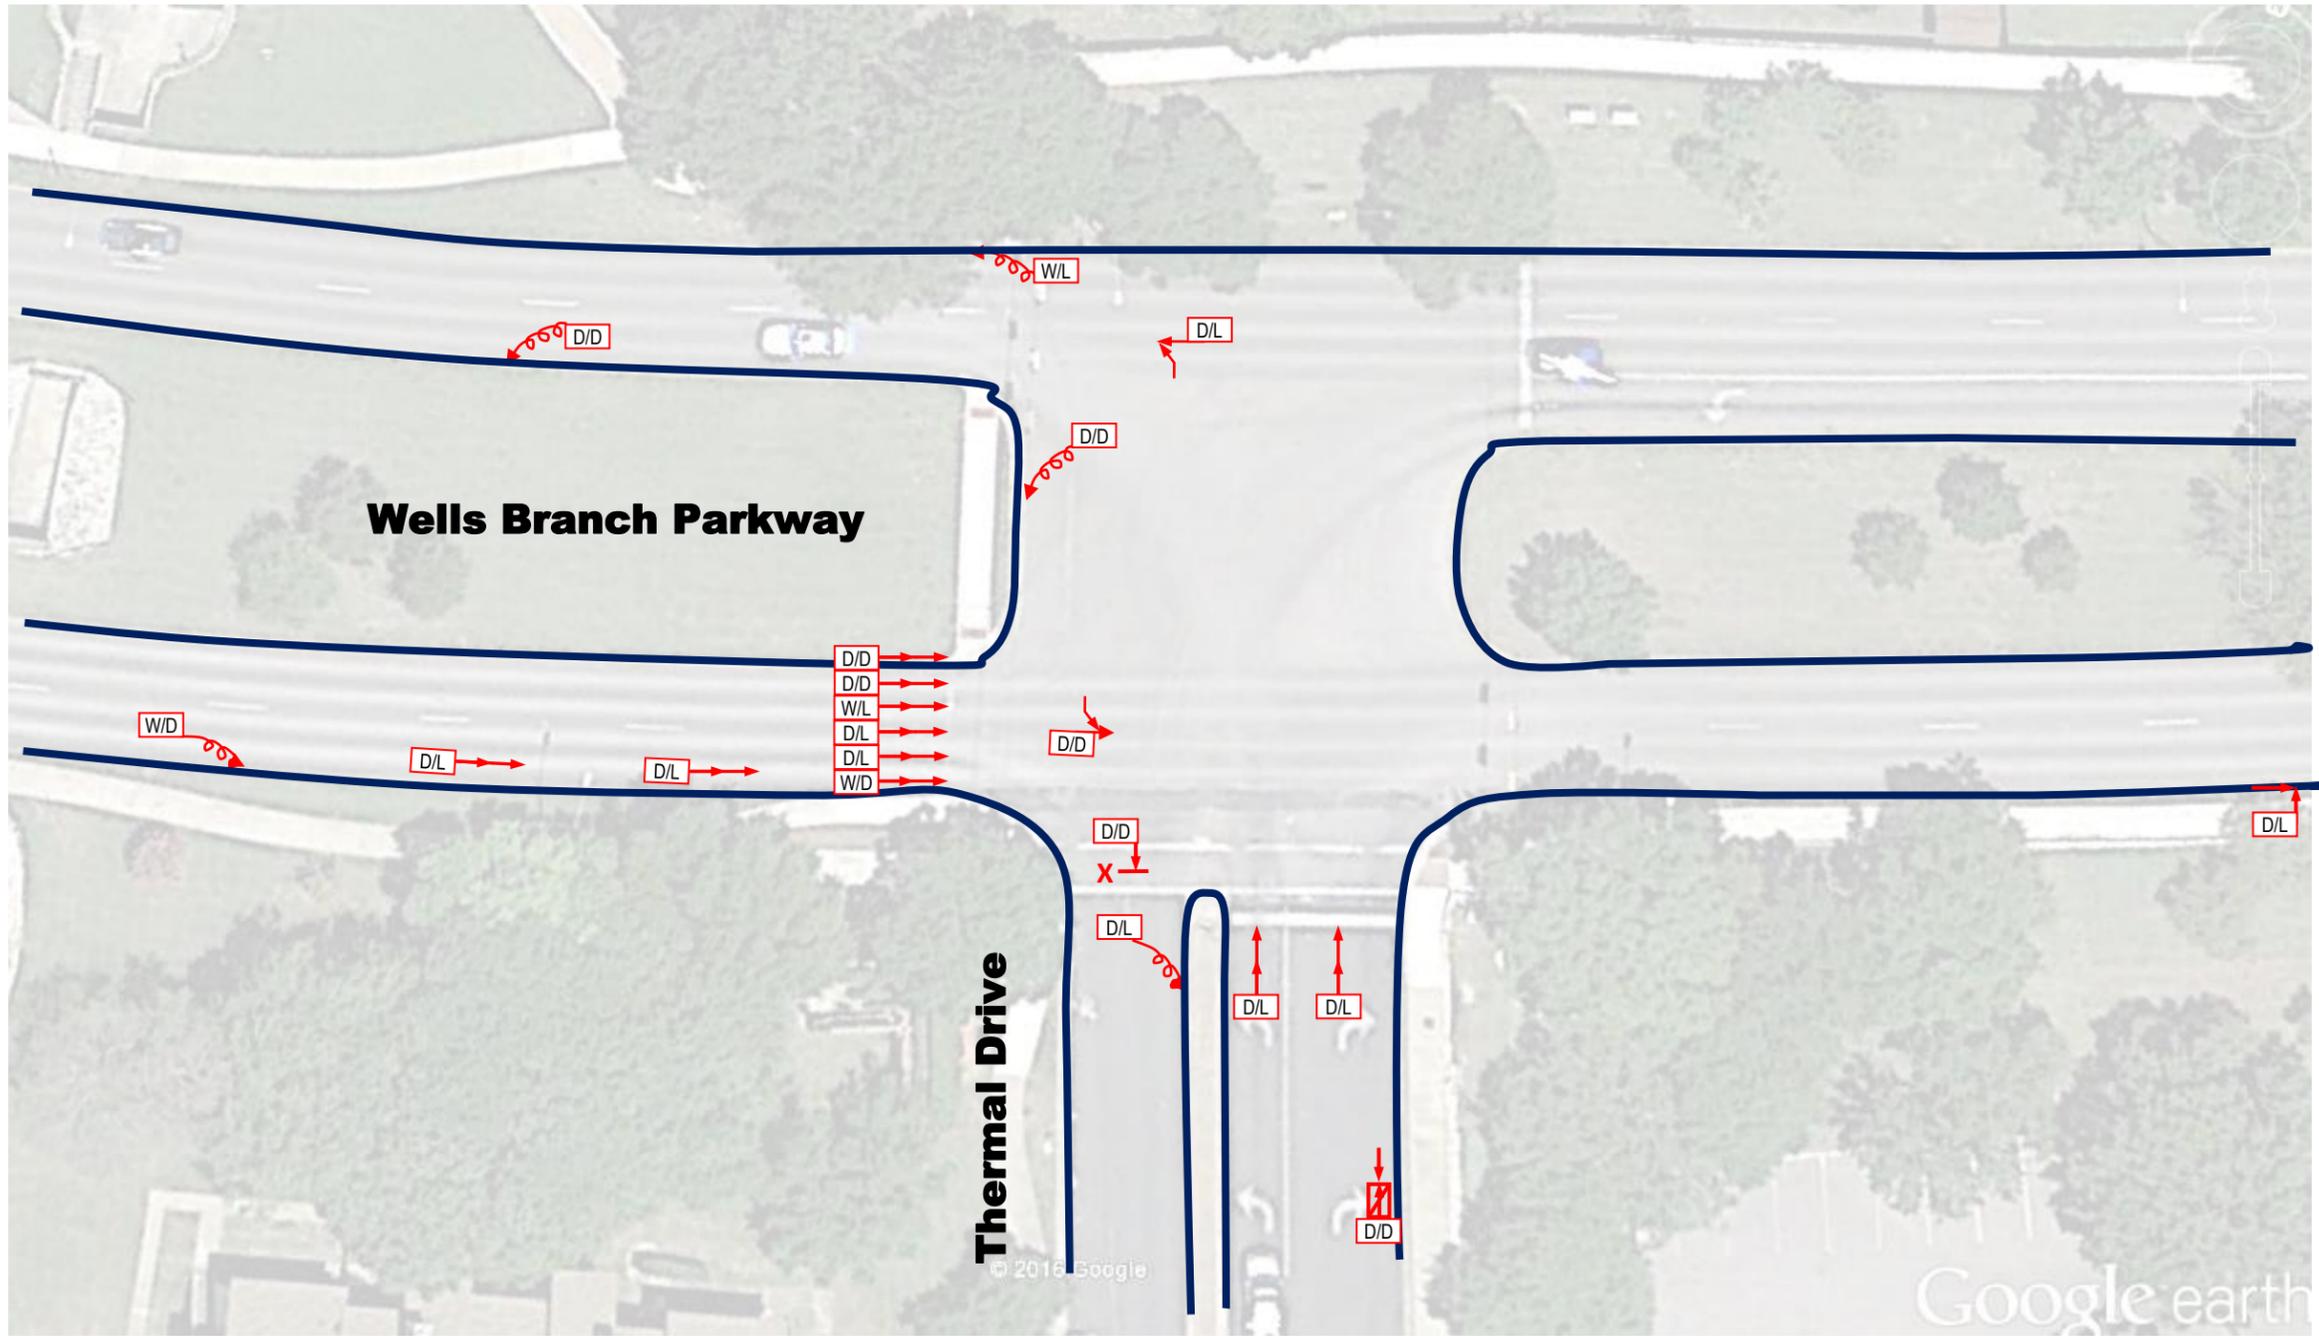
Wells Branch Parkway at Thermal Drive Intersection

The majority of collisions were either rear-end or fixed object collisions. Almost half of the accidents took place at night. The reasons for these accidents may be the visibility, drivers' inattention or failing to yield right-of-way.

FY	Crash ID	Crash Date YYYYMMDD	Crash Time 2400	Surface Conditions	Light Conditions	Weather Conditions	Block	Roadway	Intersection Reference	Location	Vehicles Involved	Accident Type	Injured	Contributing Factors	Comments
13	13127095	20130215	7:10	1 = Dry	1 = Daylight	1 = Clear	1800	Wells Branch Parkway	Thermal Drive	20' W	2	Rear End	1	22 = Failed to Control Speed	Both Vehicles were traveling EB
13	13152164	20130304	8:54	1 = Dry	1 = Daylight	1 = Clear	14100	Thermal Drive	Wells Branch Parkway	at	3	Rear End	1	22 = Failed to Control Speed	All Vehicles were traveling NB
13	13193416	20130326	2:51	1 = Dry	3 = Dark, Lighted	1 = Clear	14100	Thermal Drive	Wells Branch Parkway	170' S	3	Head On	0	71 = Wrong Way – One Way Road	Hit and Run, EB to SB RT Vehicle went on the wrong
13	13271056	20130513	15:40	1 = Dry	1 = Daylight	1 = Clear	14100	Thermal Drive	Wells Branch Parkway	10' S	2	Rear End	1	22 = Failed to Control Speed	NB Vehicle Hit a Stopped Vehicle from behind

13	13273564	20130518	15:30	1 = Dry	1 = Daylight	1 = Clear	1800	Wells Branch Parkway	Thermal Drive	50' W	2	Rear End	1	22 = Failed to Control Speed	DWI, EB Vehicle Hit a Stopped Vehicle from
13	13422254	20130827	10:20	2 = Wet	1 = Daylight	3 = Rain	1800	Wells Branch Parkway	Thermal Drive	20' W	1	Out of Control	0	60 = Unsafe Speed	Single Vehicle accident, NB to WB LT Vehicle skid and
14	13525792	20131031	8:01	2 = Wet	1 = Daylight	3 = Rain	1800	Wells Branch Parkway	Thermal Drive	at	2	Rear End	1	22 = Failed to Control Speed	Both Vehicles were traveling EB
14	13571500	20131130	19:47	1 = Dry	3 = Dark, Lighted	1 = Clear	1800	Wells Branch Parkway	Thermal Drive	at	2	Left Turn	4	15 = Disregard Stop and Go Signal	Hit and Run, EB Vehicle hit WB to SB LT Vehicle,
14	13581641	20131205	13:20	1 = Dry	1 = Daylight	2 = Cloudy	1800	Wells Branch Parkway	Thermal Drive	at	2	Left Turn	0	15 = Disregard Stop and Go Signal	WB Vehicle ran the red light and hit a NB to WB

14	13584334	20131130	22:11	1 = Dry	3 = Dark, Lighted	1 = Clear	1800	Wells Branch Parkway	Thermal Drive	50' W	1	Out of Control	0	67 = Under Influence – Alcohol	Single Vehicle accident, WB Vehicle lost control
14	13597098	20131213	18:56	2 = Wet	3 = Dark, Lighted	3 = Rain	1800	Wells Branch Parkway	Thermal Drive	100'W	1	Out of Control	0	22 = Failed to Control Speed	Single Vehicle accident, EB Vehicle lost control and
14	13706687	20140225	6:50	2 = Wet	5 = Dawn	6 = Fog	1800	Wells Branch Parkway	Thermal Drive	at	2	Rear End	0	22 = Failed to Control Speed	Both Vehicles were traveling EB
14	13754929	20140326	18:25	1 = Dry	1 = Daylight	1 = Clear	1800	Wells Branch Parkway	Thermal Drive	at	3	Rear End	1	20 = Driver Inattention	3 Vehicle Accident, EB Vehicle rear-ended a
14	13762506	20140331	18:08	1 = Dry	1 = Daylight	1 = Clear	1800	Wells Branch Parkway	Thermal Drive	at	2	Rear End	0	44 = Followed Too Closely	Both Vehicles were traveling EB

14	13942760	20140725	15:33	1 = Dry	1 = Daylight	1 = Clear	1801	Wells Branch Parkway	Thermal Drive	at	2	Right Angle	1	20 = Driver Inattention	Vehicle hit a bicycle
15	14324962	20150314	22:12	1 = Dry	3 = Dark, Lighted	1 = Clear	1800	Wells Branch Parkway	Thermal Drive	at	2	Rear End	0	22 = Failed to Control Speed	Both Vehicles were traveling EB
15	14425168	20150425	2:07	1 = Dry	3 = Dark, Lighted	1 = Clear	1800	Wells Branch Parkway	Thermal Drive	at	1	Out of Control	1	60 = Unsafe Speed	Single Vehicle accident, WB Vehicle lost control
15	14461293	20150531	21:31	1 = Dry	3 = Dark, Lighted	1 = Clear	1819	Wells Branch Parkway	Thermal Drive	at	2	Right Angle	1	20 = Driver Inattention	EB to SB RT Vehicle hit a pedestrian
15	14517805	20150704	21:47	1 = Dry	3 = Dark, Lighted	1 = Clear	1800	Wells Branch Parkway	Thermal Drive	at	2	Rear End	0	20 = Driver Inattention	Hit and Run, Both Vehicles were traveling EB
15	14553694	20150726	11:45	1 = Dry	1 = Daylight	1 = Clear	14100	Wells Branch Parkway	Thermal Drive	at	1	Out of Control	1	60 = Unsafe Speed	EB to SB RT Motor Cycle lost control and hit the

The existing landscaping adjacent to Wells Branch Parkway and on central medians needs continuous grooming to provide adequate sight distance and better visibility to improve the safety conditions for all road users.

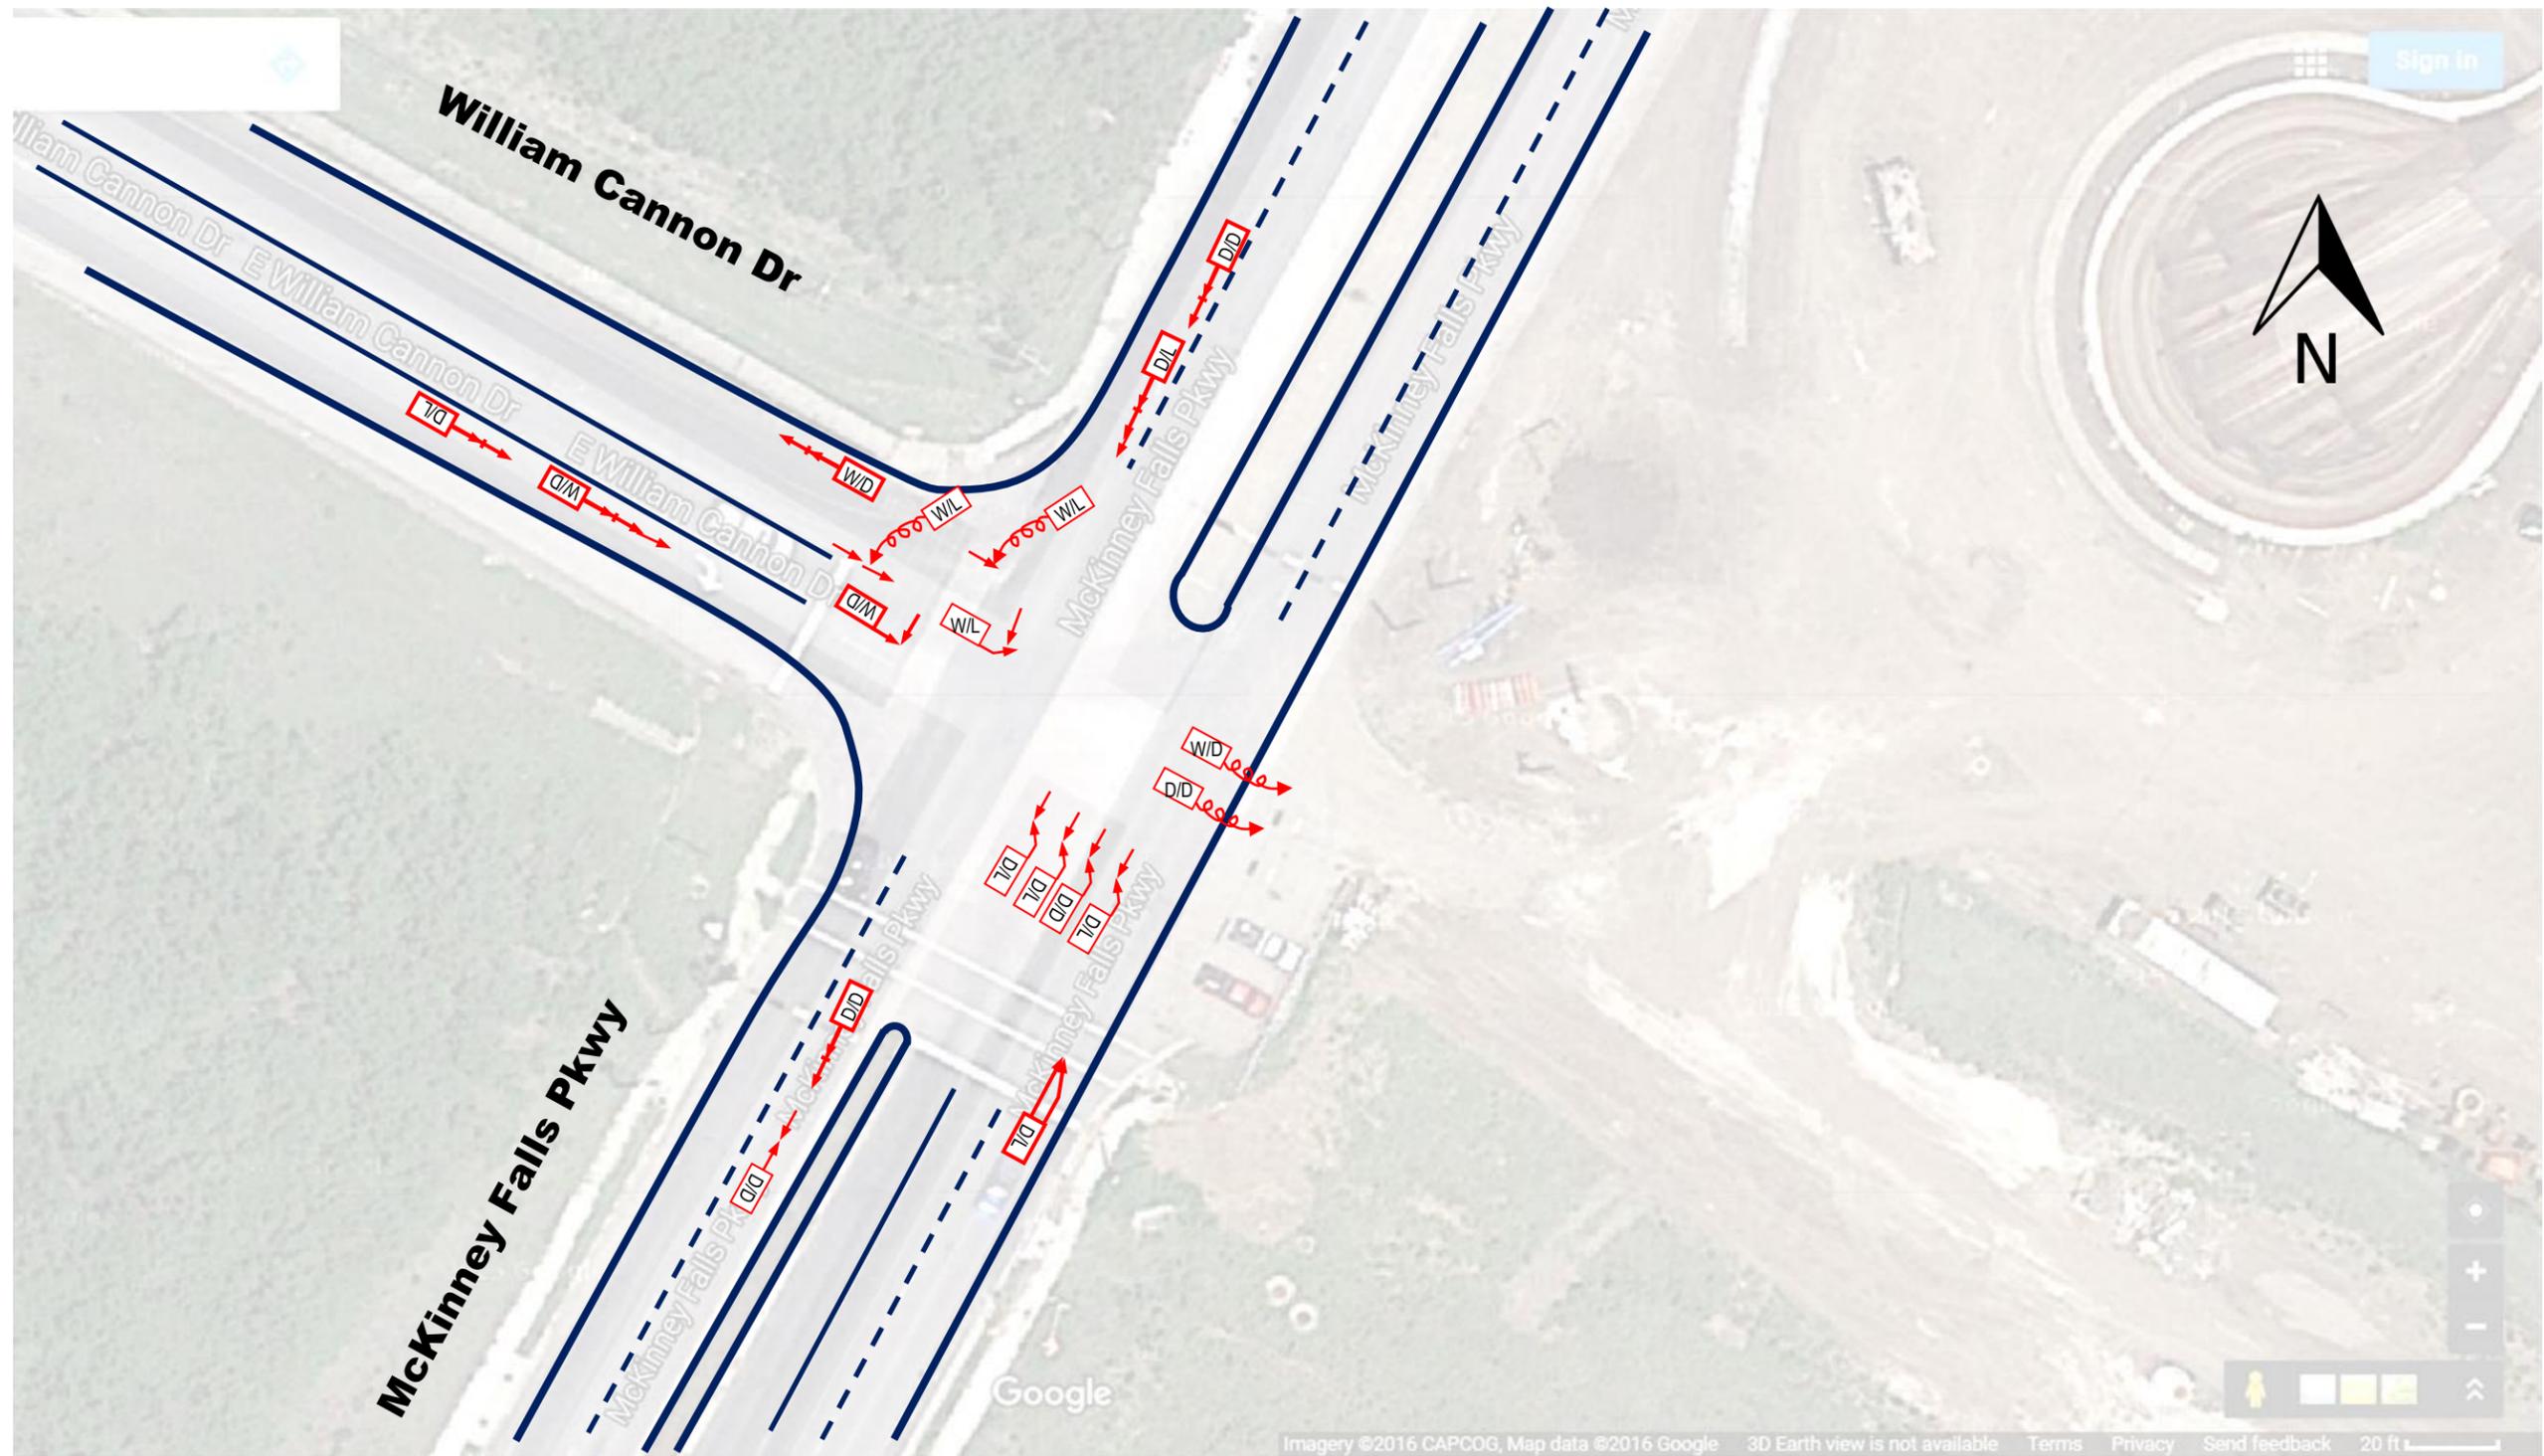
McKinney Falls Pkwy at William Cannon Dr.

Vehicles at the minor road approach are failing to yield the right-of-way to the major road motor traffic. South and east bound accidents account for 9 out of 10 collisions for the previous 3 fiscal years. Limited sight visibility from the minor road approach may be the primary cause, due to road geometry. High speeds on the major road approach (SB McKinney Falls Parkway) may also be a factor.

All advance warning signage appears to be adequate, in good repair. This is a re-aligned / re-designed "T" intersection with non-perpendicular road geometry, where the primary through travel lanes are: A southbound McKinney Falls Parkway with a current speed limit of 55 MPH, (along a horizontal & vertical curve approach) which transitions to a northbound Thaxton Road signed for 45 MPH; and is intersected by the minor road (within the curve) – the remaining segment of Thaxton Road. This "T" intersection includes and encompasses said horizontal and vertical curves, road geometry, which may affect visibility & restrict sight distance, and may be a major contributing factor, per reported collision reports.

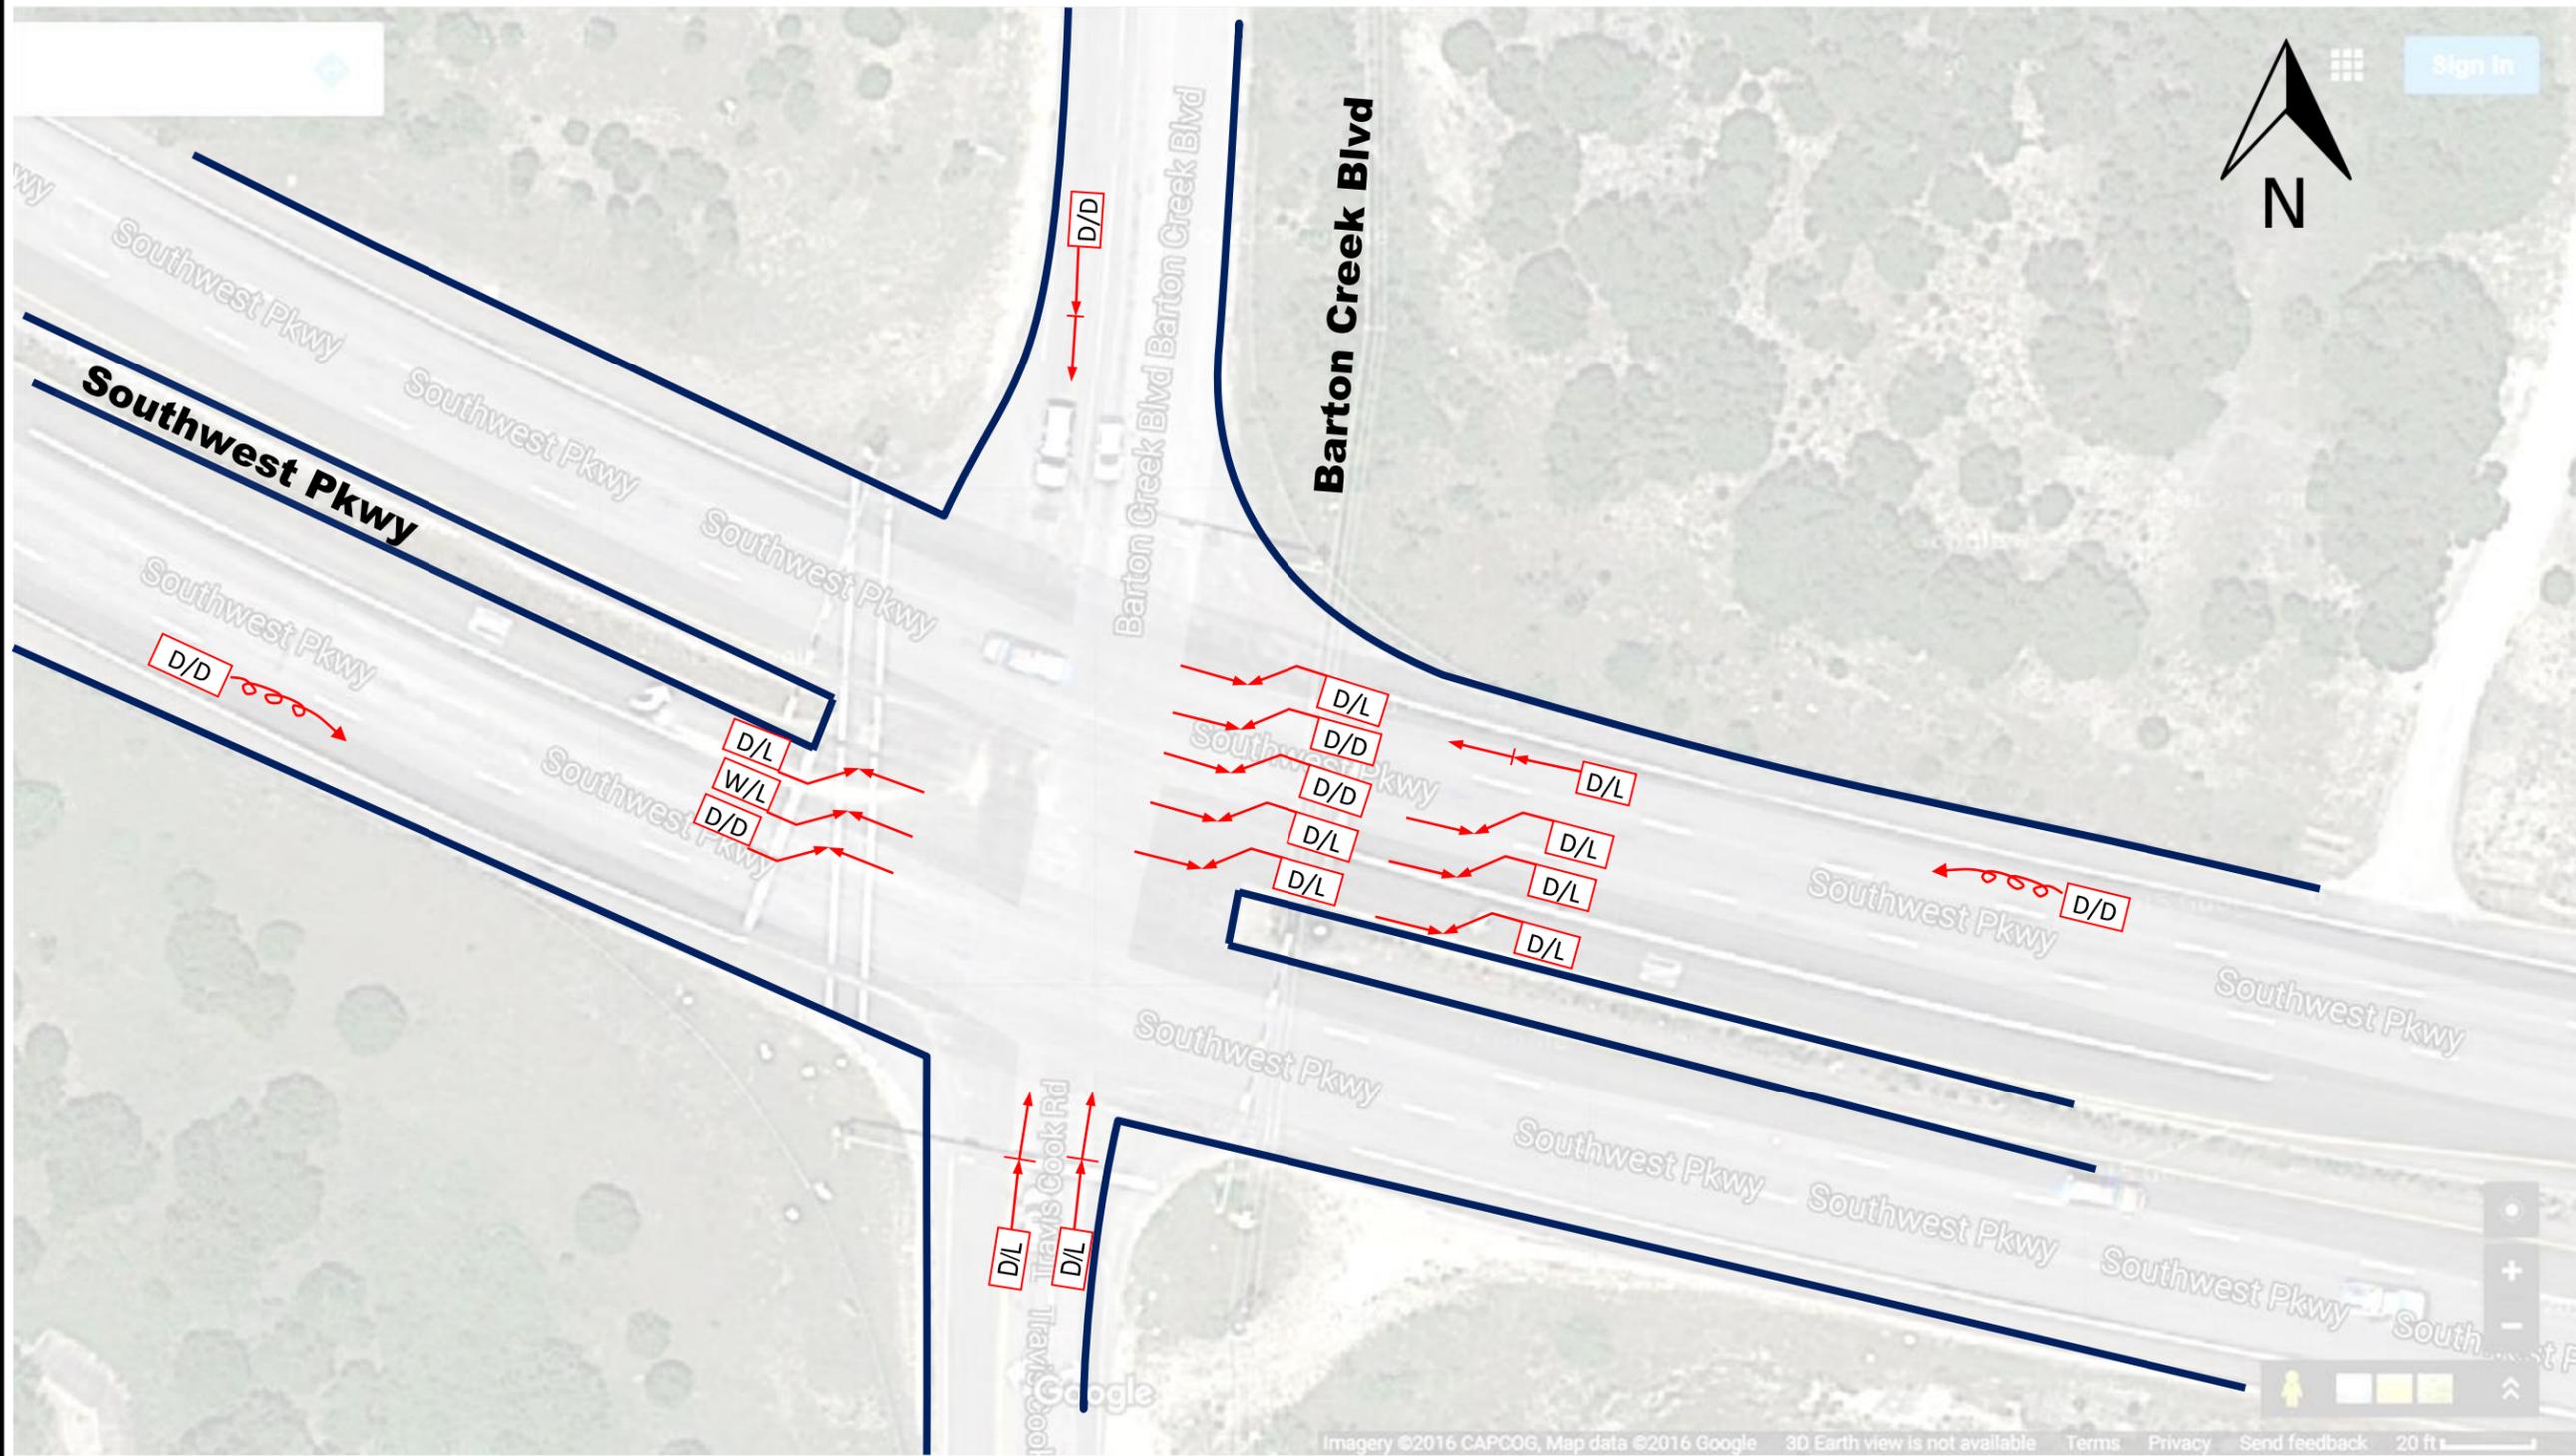
Southwest Pkwy at Barton Creek Blvd
12/31/2015

The highest accident type is Left Turns failing to yield ROW (50%) followed by rear ends (25%).

FY	Crash ID	Crash Date YYYYMMDD	Crash Time 2400	Surface Conditions	Light Conditions	Weather Conditions	Block	Roadway	Intersection Reference	Location	Vehicles Involved	Accident Type	Injured	Contributing Factors	Comments
13	12998455	20121126	1645	1 = Dry	1 = Daylight	1 = Clear		Southwest Pkwy	Barton Creek Blvd		2	Left Turn	0	37 = Failed to Yield ROW – Turning Left	
13	13389499	20130621	203	1 = Dry	3 = Dark, Lighted	1 = Clear		Southwest Pkwy	Barton Creek Blvd		1	Out of Control	0	19 = Distraction in Vehicle	
13	13474598	20130921	2355	1 = Dry	3 = Dark, Lighted	1 = Clear		Southwest Pkwy	Barton Creek Blvd		2	Rear End	0	22 = Failed to Control Speed	20 = Driver Inattention
14	13657066	20140119	1130	1 = Dry	1 = Daylight	1 = Clear		Southwest Pkwy	Barton Creek Blvd		2	Rear End	0	22 = Failed to Control Speed	
14	13725060	20140307	2000	1 = Dry	3 = Dark, Lighted	1 = Clear		Southwest Pkwy	Barton Creek Blvd		2	Left Turn	1	37 = Failed to Yield ROW – Turning Left	20 = Driver Inattention

14	13755858	20140325	1329	1 = Dry	1 = Daylight	1 = Clear		Southwest Pkwy	Barton Creek Blvd		2	Left Turn	2	37 = Failed to Yield ROW – Turning Left	
14	13786253	20140411	730	2 = Wet	1 = Daylight	3 = Rain		Southwest Pkwy	Barton Creek Blvd		2	Left Turn	1	37 = Failed to Yield ROW – Turning Left	
14	13948282	20140729	2133	1 = Dry	3 = Dark, Lighted	1 = Clear		Southwest Pkwy	Barton Creek Blvd		2	Left Turn	0	37 = Failed to Yield ROW – Turning Left	
14	14037368	20140925	1855	1 = Dry	1 = Daylight	1 = Clear		Southwest Pkwy	Barton Creek Blvd		2	Rear End	0	20 = Driver Inattention	22 = Failed to Control Speed
14	14050052	20140928	013	1 = Dry	3 = Dark, Lighted	1 = Clear		Southwest Pkwy	Barton Creek Blvd		1	Out of Control	0	67 = Under Influence – Alcohol	
15	14050761	20141003	1520	1 = Dry	1 = Daylight	1 = Clear		Southwest Pkwy	Barton Creek Blvd		2	Left Turn	0	37 = Failed to Yield ROW – Turning Left	
15	14056897	20141006	1516	1 = Dry	1 = Daylight	1 = Clear		Southwest Pkwy	Barton Creek Blvd		2	Left Turn	0	37 = Failed to Yield ROW – Turning Left

15	14127178	20141117	1248	1 = Dry	1 = Daylight	1 = Clear		Southwest Pkwy	Barton Creek Blvd		2	Left Turn	0	37 = Failed to Yield ROW – Turning Left	
15	14285883	20150219	1833	1 = Dry	3 = Dark, Lighted	1 = Clear		Southwest Pkwy	Barton Creek Blvd		3	Left Turn	1	37 = Failed to Yield ROW – Turning Left	
15	14358853	20150402	820	1 = Dry	1 = Daylight	1 = Clear		Southwest Pkwy	Barton Creek Blvd		2	Rear End	0	22 = Failed to Control Speed	
15	14370597	20150409	1628	1 = Dry	1 = Daylight	1 = Clear		Southwest Pkwy	Barton Creek Blvd		2	Left Turn	0	37 = Failed to Yield ROW – Turning Left	
15	14583788	20150811	1830	1 = Dry	1 = Daylight	1 = Clear		Southwest Pkwy	Barton Creek Blvd		2	Left Turn	2	37 = Failed to Yield ROW – Turning Left
