Road Maintenance, Traffic Program
INTRA-DEPARTMENT MEMORANDUM

FY 2016 High Collision Locations Report

TNR Road Maintenance, Traffic Program

January 2016

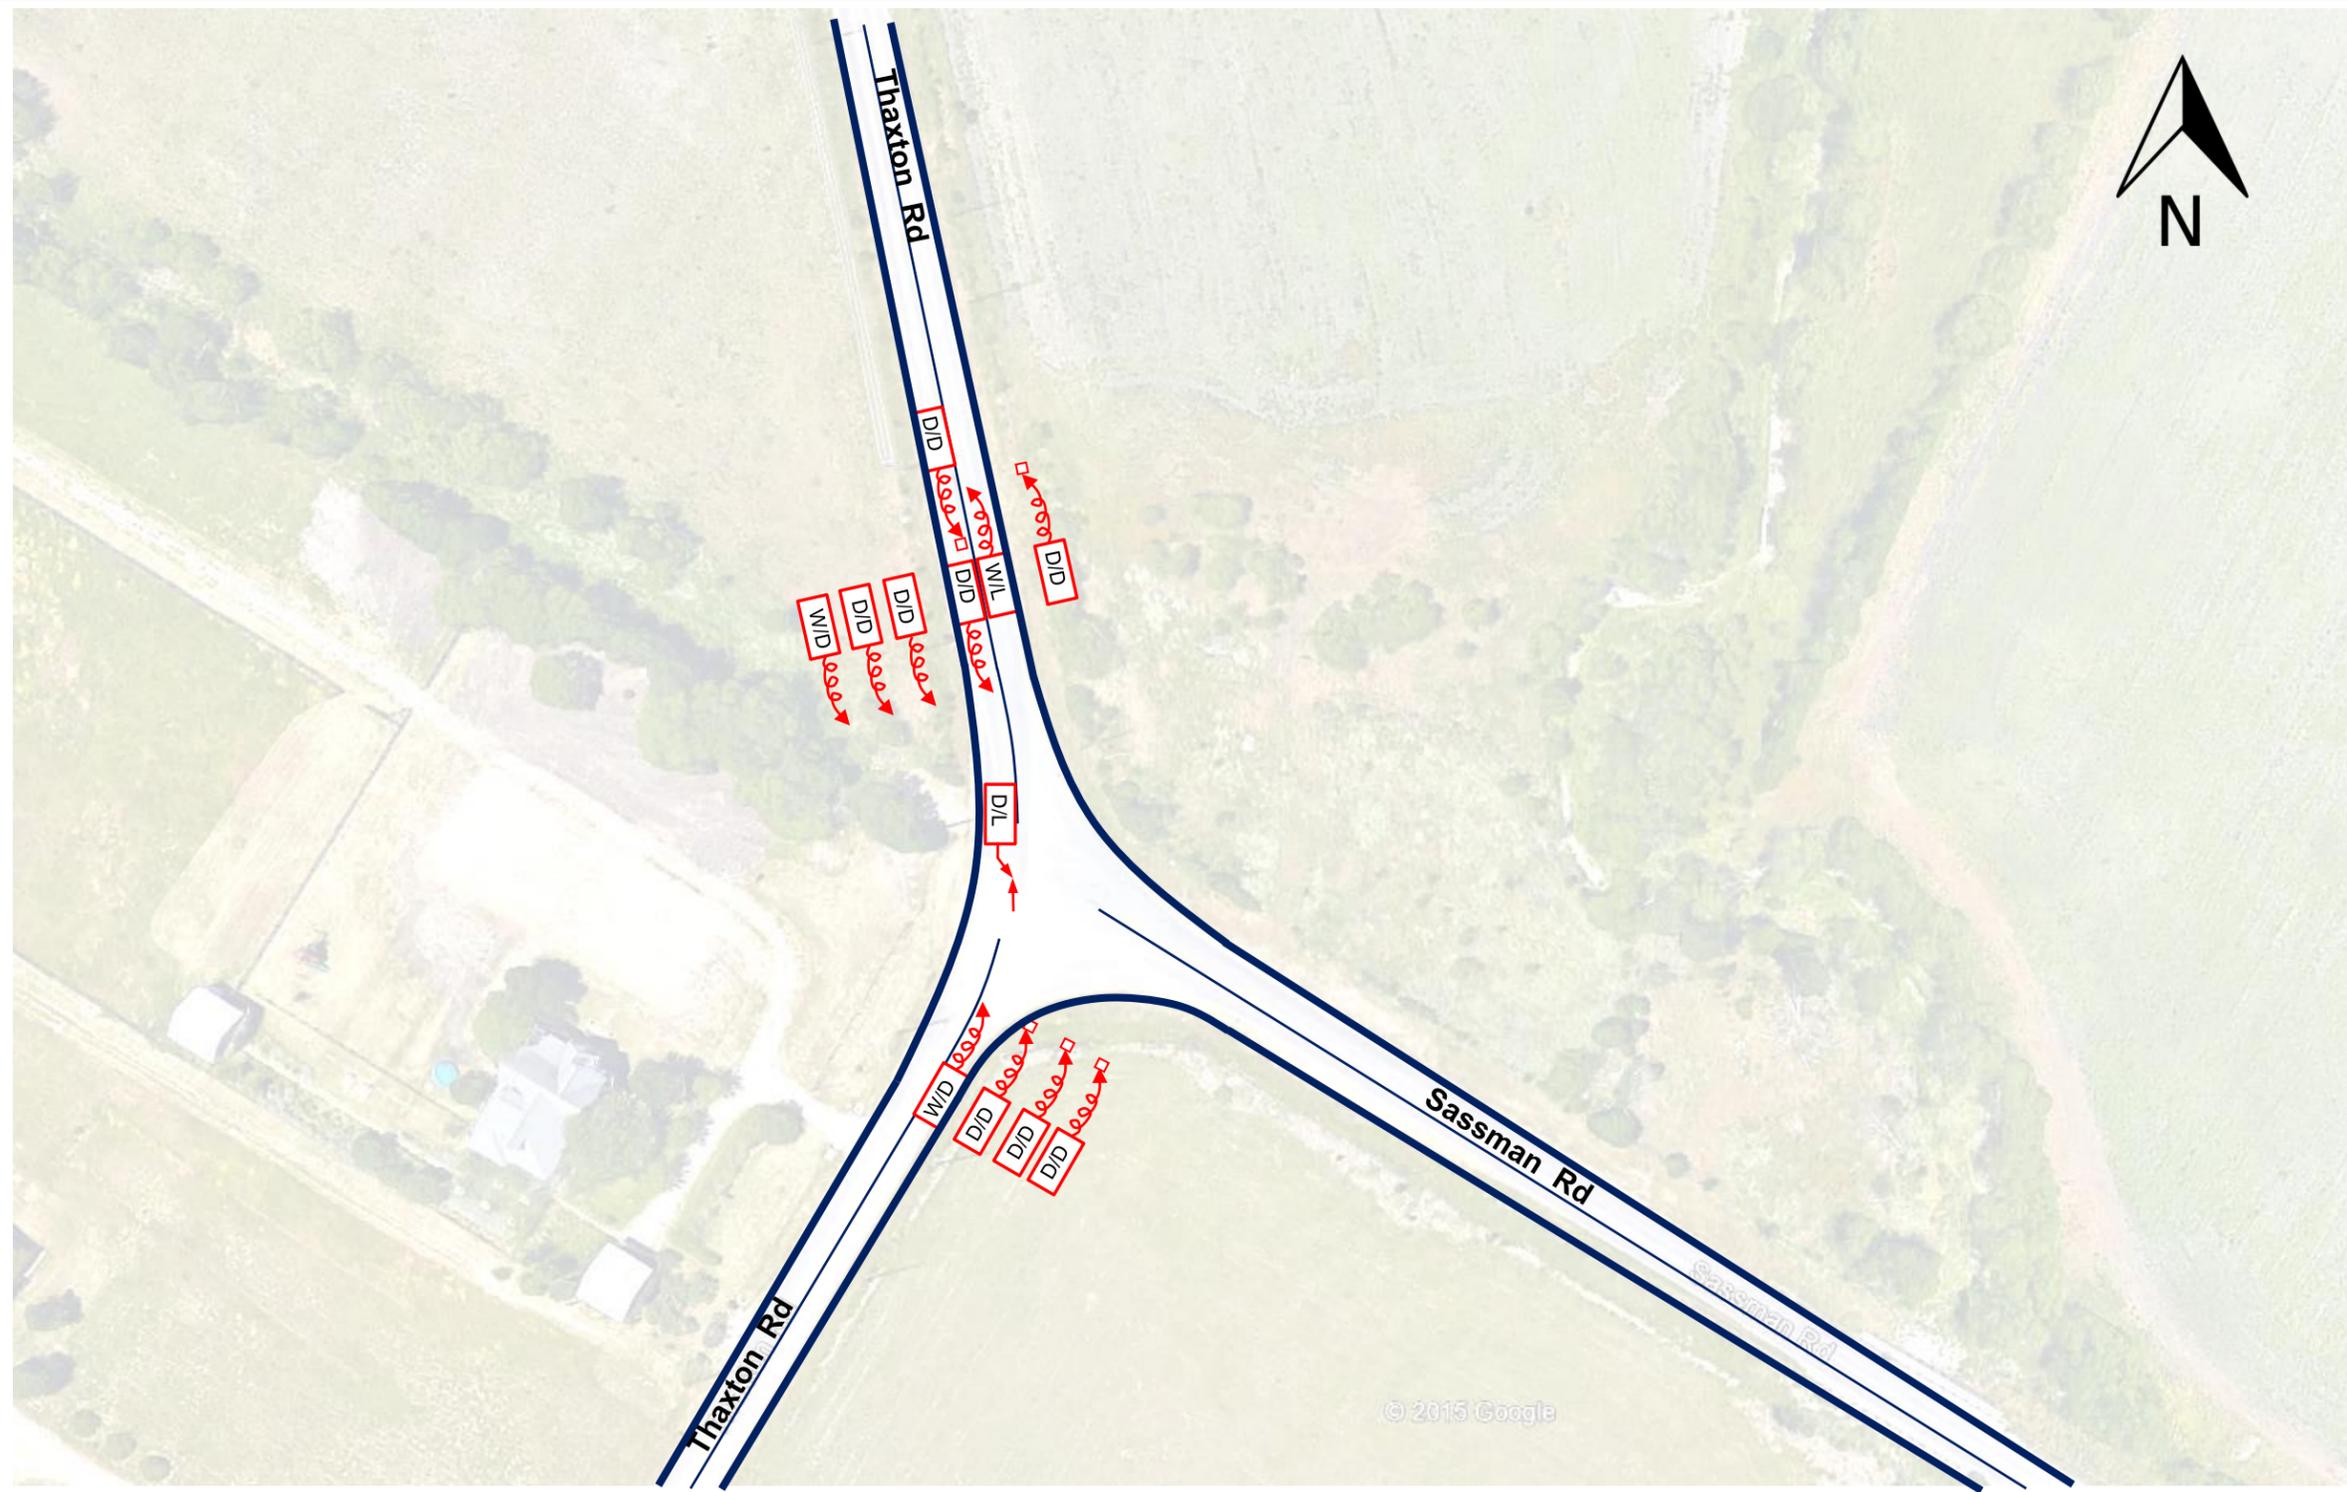
Thaxton Road at Sassman road
01/05/2016

There is only one right angle, and no tangent lane continuity, and vehicles approach from long tangent segments of rural roadway at excessive speeds, and lose control. The north and southbound approaches are Thaxton Road and are the through travel lanes, with Sassman Road being the westbound approach and having a Yield Sign for traffic control. Current warning signage (and advisory speed plaques) on both approaches of Thaxton Road, and Large Arrow Board signs appear to be adequate, as does the striping and condition of the Raised Pavement Markers. Failure to heed or a disregard signs by motorists is suspected. Alcohol may also be a contributing factor. Restricted visibility and sight distance do not appear to be problems to motorists at these intersection approaches.

FY	Crash ID	Crash Date YYYYMMDD	Crash Time 2400	Surface Conditions	Light Conditions	Weather Conditions	Block	Roadway	Intersection Reference	Location	Vehicles Involved	Accident Type	Injured	Contributing Factors	Comments
13	13029457	20121207	307	1 = Dry	3 = Dark, Lighted	1 = Clear	8900	Thaxton Rd	Sassman Rd	Intersection	1	Out of Control	0	41 = Faulty Evasive Action	& 45 = Had Been Drinking
13	13060663	20130106	2056	1 = Dry	2 = Dark, Not Lighted	1 = Clear	8900	Thaxton Rd	Sassman Rd	Intersection	1	Out of Control	0	22 = Failed to Control Speed	& 45 = Had Been Drinking
13	13138780	20130222	2323	1 = Dry	2 = Dark, Not Lighted	1 = Clear	8900	Thaxton Rd	Sassman Rd	50 FT S	1	Out of Control	0	22 = Failed to Control Speed	& 20 = Driver Inattention
13	13218253	20130414	332	1 = Dry	2 = Dark, Not Lighted	1 = Clear	8900	Thaxton Rd	Sassman Rd	Intersection	1	Out of Control	0	22 = Failed to Control Speed	& 45 = Had Been Drinking

13	13394762	20130807	1426	1 = Dry	1 = Daylight	1 = Clear	8900	Thaxton Rd	Sassman Rd	Intersection	2	Left Turn	0	37 = Failed to Yield ROW – Turning Left	
14	13833346	20140514	737	2 = Wet	2 = Dark, Not Lighted	3 = Rain	8900	Thaxton Rd	Sassman Rd	Intersection	1	Out of Control	0	17 = Disregard Turn Marks at Intersection	& 20 = Driver Inattention, 22 = Fail. To Control Sp.
14	13903507	20140629	717	1 = Dry	2 = Dark, Not Lighted	1 = Clear	8900	Thaxton Rd	Sassman Rd	Intersection	1	Out of Control	0	60 = Unsafe Speed	
14	13946101	20140728	237	1 = Dry	2 = Dark, Not Lighted	1 = Clear	8900	Thaxton Rd	Sassman Rd	Intersection	1	Out of Control	0		
15	14097971	20141031	700	2 = Wet	2 = Dark, Not Lighted	3 = Rain	8900	Thaxton Rd	Sassman Rd	Intersection	1	Out of Control	0	22 = Failed to Control Speed	
15	14247235	20140129	729	2 = Wet	1 = Daylight	2 = Cloudy	8800	Thaxton Rd	Sassman Rd	193 FT N	1	Out of Control	0	60 = Unsafe Speed

15	14275828	20140215	035	1 = Dry	2 = Dark, Not Lighted	1 = Clear	8800	Thaxton Rd	Sassman Rd	154 FT N	1	Out of Control	0	41 = Faulty Evasive Action	
15	14576740	20150802	411	1 = Dry	2 = Dark, Not Lighted	1 = Clear	9000	Thaxton Rd	Sassman Rd	Intersection	1	Out of Control	1	67 = Under Influence – Alcohol

Installation of chevrons to accompany the existing large arrow boards, and confirm the existing road geometry, at both approaches, is recommended. New warning signs to replace weathered and older signs having less than desired retro-reflectivity should also help.

Replace all older and missing raised pavement markers, at all approaches. Continue to evaluate of monitor accident reports.

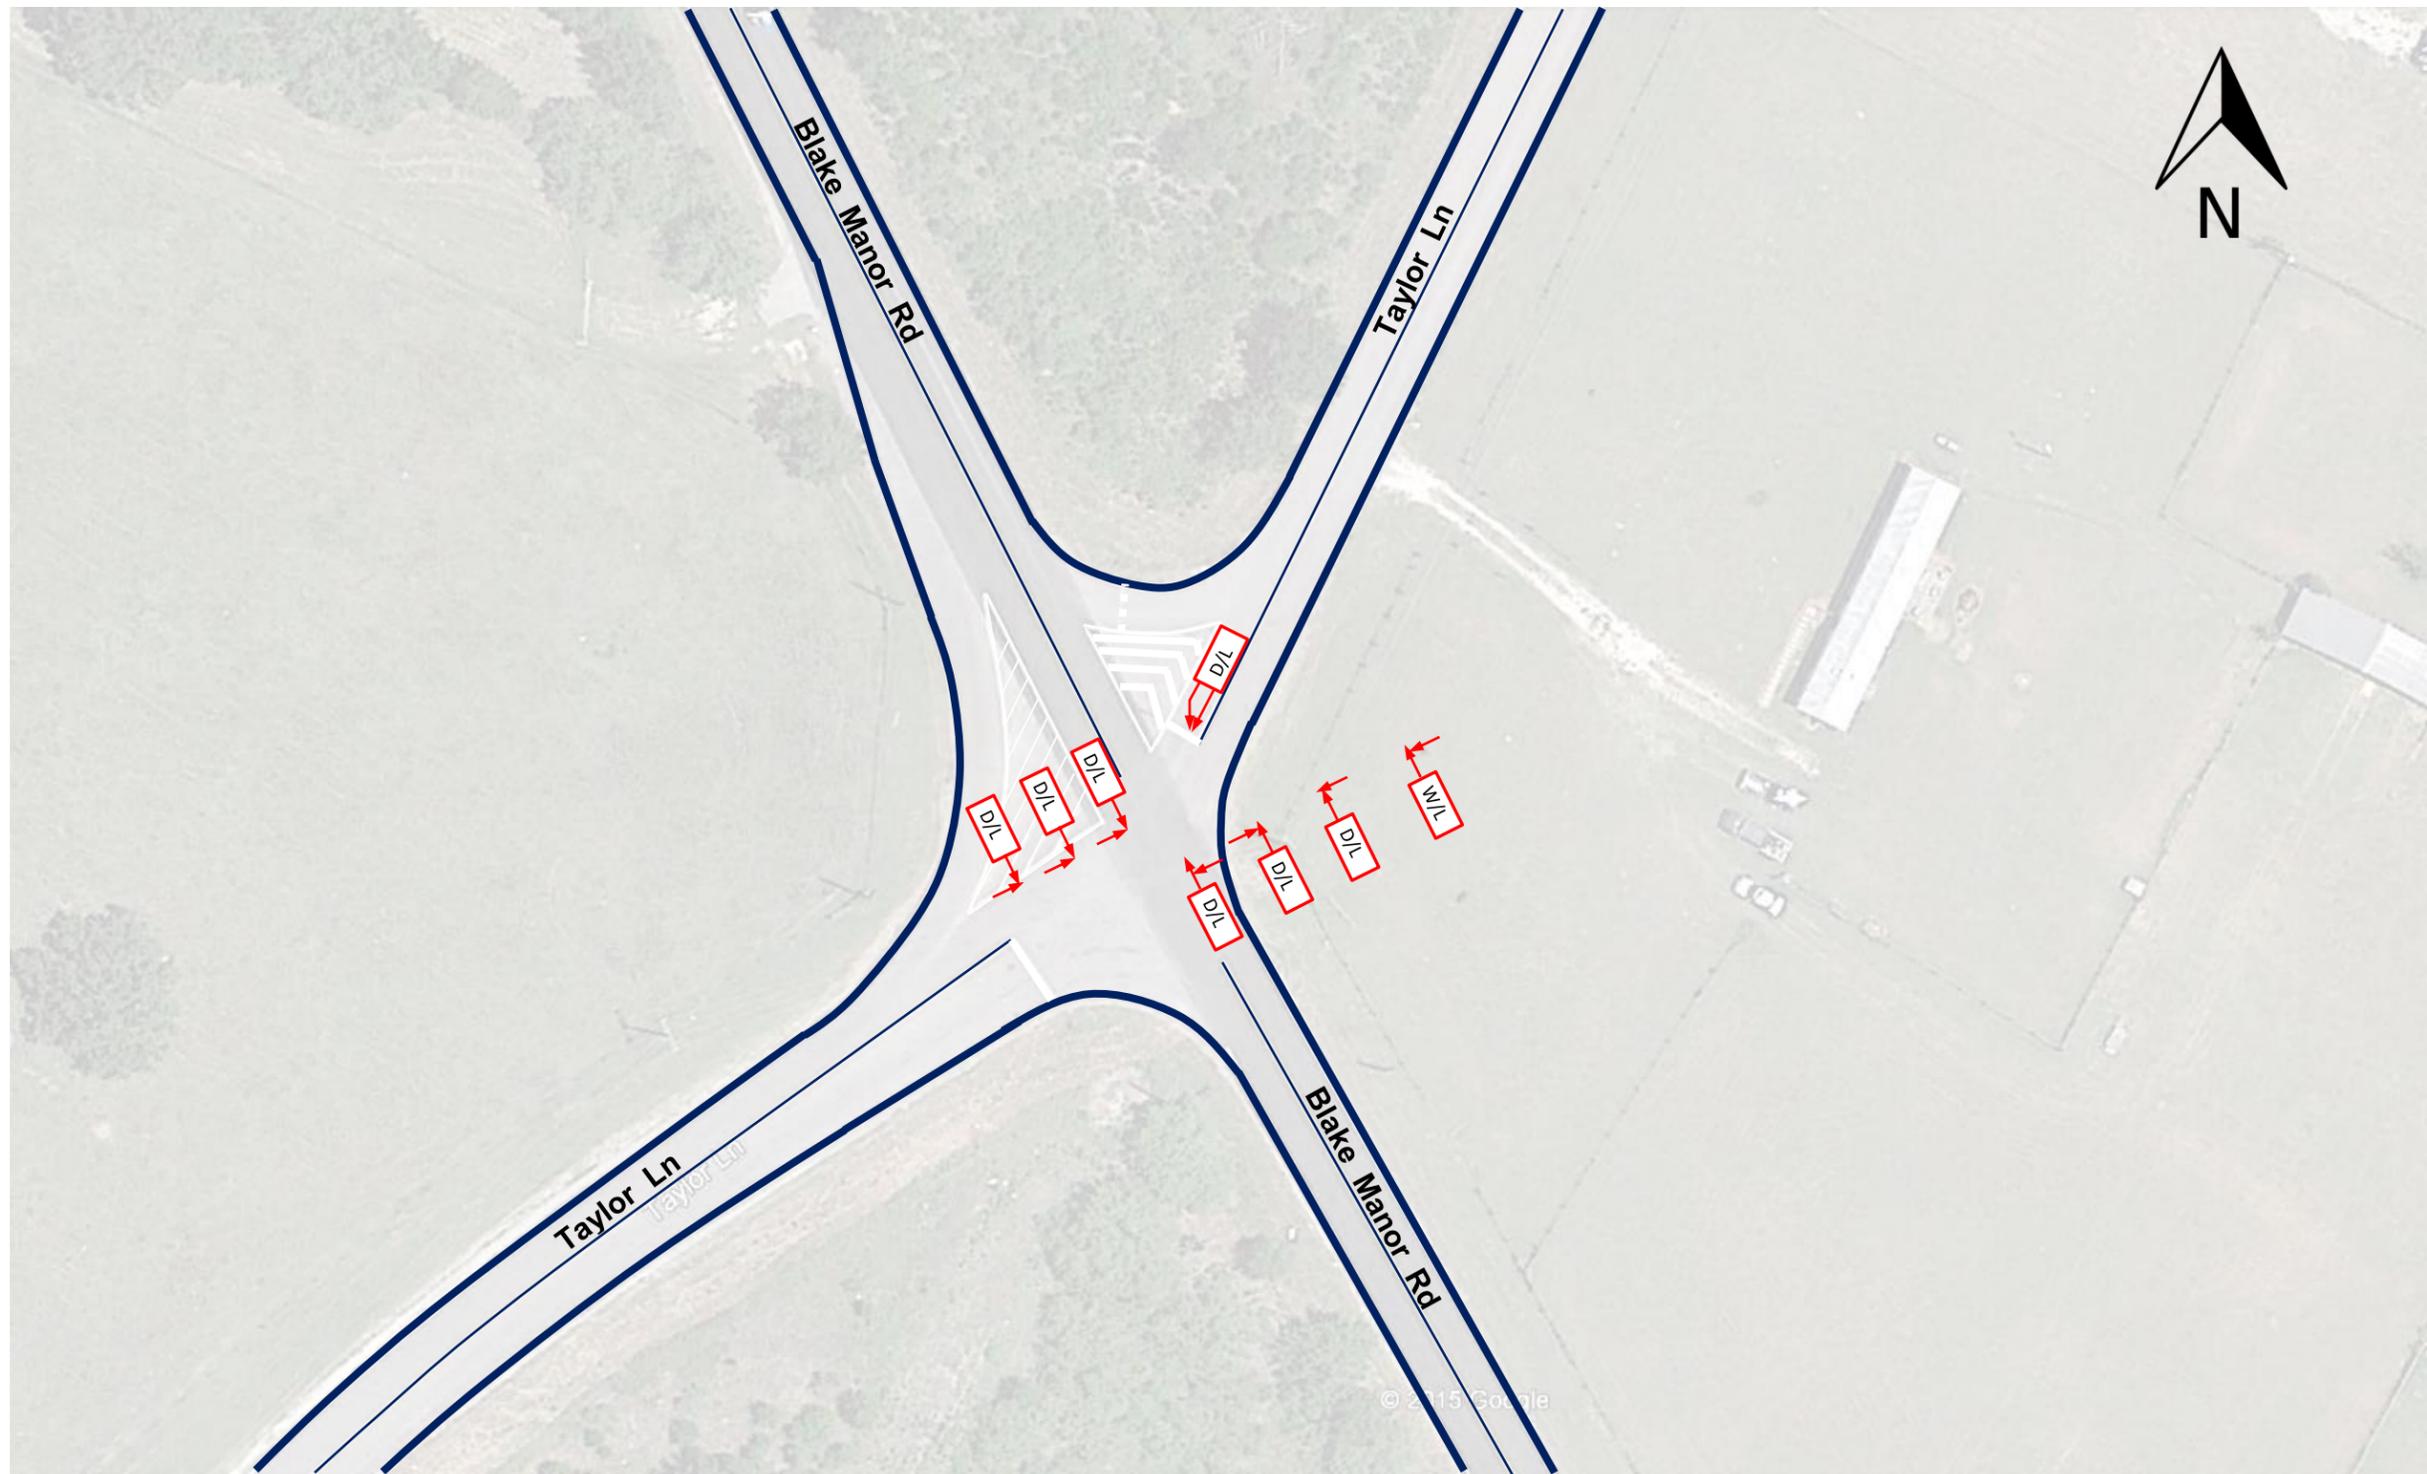
Blake Manor Road at Taylor Lane

Vehicles at the minor road approach are failing to yield the right-of-way to the major road. There does not appear to be any restricted or obstructed views, visibility, except for the southwest bound minor road approach when looking northwest. This is likely due to the unusual non-perpendicular road geometry, and occasional excessive roadside vegetation overgrowth. A possible misperception from motorists on the minor roads (that) this intersection is an all way stop, due to similar road conditions, environment for all four approaches. Another possible misperception may be the approach speeds on the major roads, as viewed by the motorists on the minor roads. The speeds are typical for these type of rural roadways.

A four leg intersection with non-perpendicular horizontal road geometry, on a largely flat grade at all approaches. All existing regulatory & warning signage appear to be appropriate and in good repair. Of note: two accident reports state collisions took place in "fog" conditions, weather.
