**Tracing in the Balcones Canyonlands Bull Creek Preserve: Lanier and Hog Wallow
Springs**

BCP Annual Report, October 2014

David A. Johns
Senior Environmental Scientist
City of Austin/Watershed Protection Department

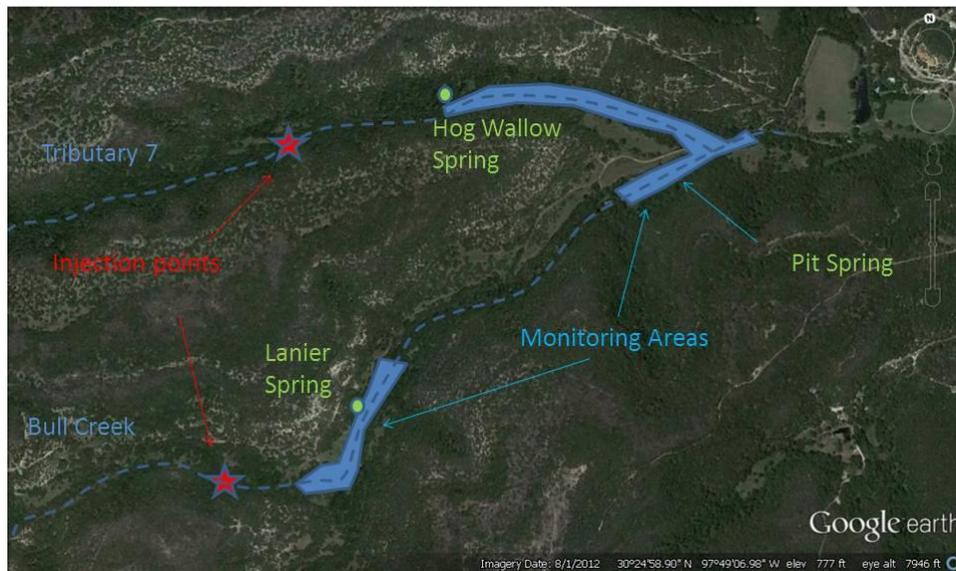
Figure 1. General dye injection and monitoring areas in the Balcones Canyonlands Preserve for the Lanier and Hog Wallow traces.

Lanier and Hog Wallow Springs provide a significant volume of water to Bull Creek and tributary 7 respectively and are sites of the rare Jollyville Plateau Salamander. Both springs discharge from alluvial deposits adjacent to the creek channels and there are no bedrock exposures in the immediate vicinity of the springs. To examine water sources for the springs, environmentally safe organic dyes were poured into the flowing water upstream of each spring and all surface flow ended upstream of each spring (Figure 1). Monitoring concluded October 16th.

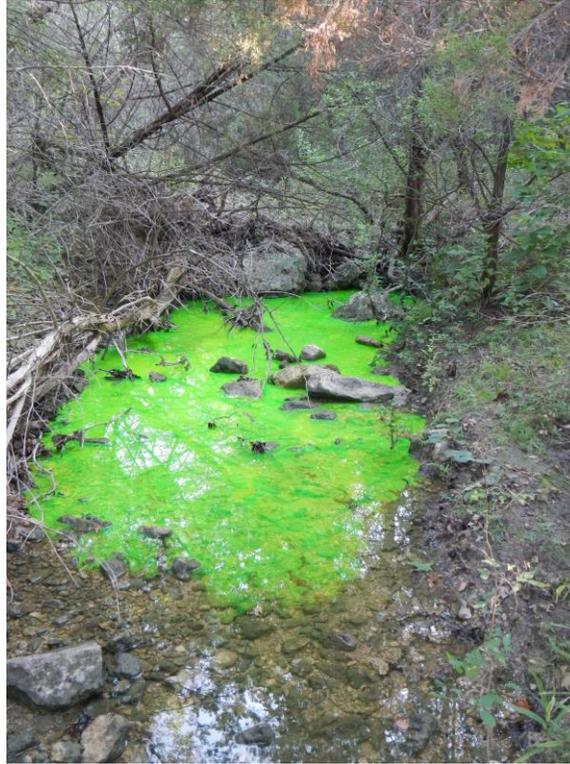
Photo 1. Injection of fluorescein dye into flowing water in tributary 7 upstream of Hog Wallow Spring on July 22nd. Surface flow ended approximately 300 ft downstream.

On July 22nd, 0.25 (1/4) pounds of fluorescein dye was poured into tributary 7 about 760 feet upstream of the spring (Photos 1 and 2). Surface flow ended approximately 300 feet downstream of the injection area. Dye was poured in 1/3 doses about 5 hours apart, beginning at 0940 and ending at 1855.

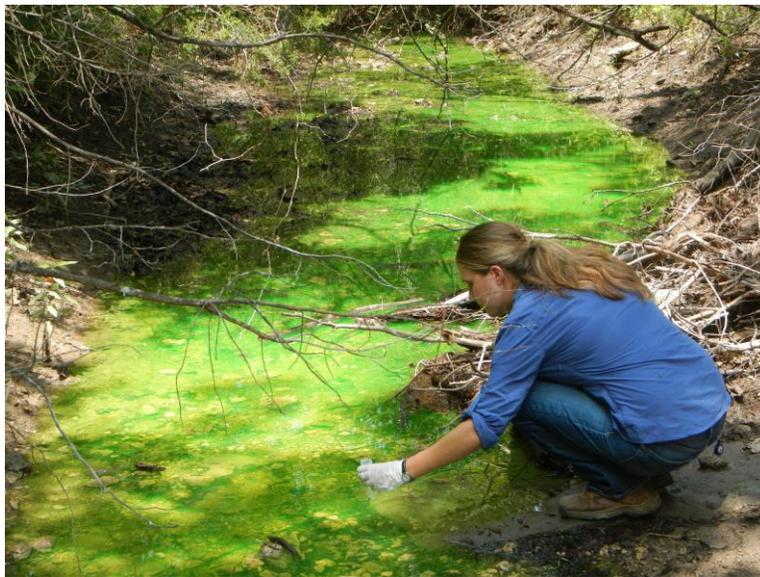
Photo 2. Watershed employee Rosemary Hatch collecting a water sample from tributary 7 following injection of dye upstream. All surface flow ended within 30 ft downstream of this location.

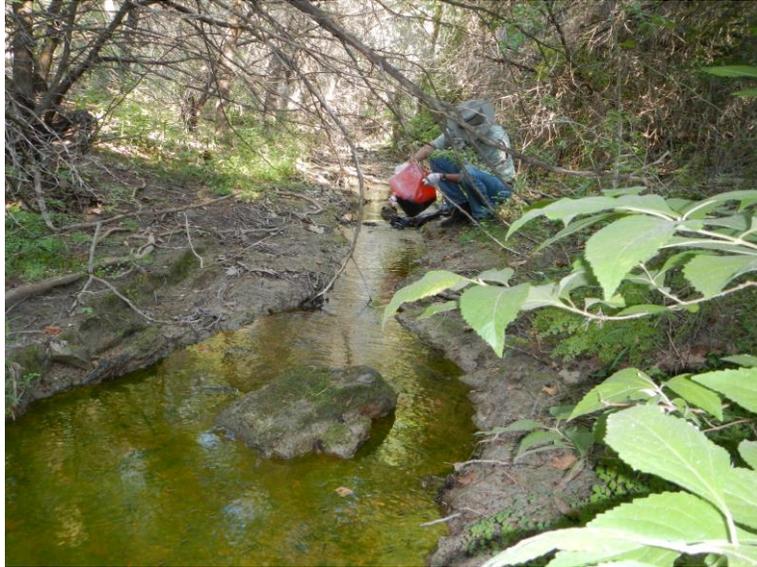
Photo 3. Watershed staff pouring eosine dye into the main channel of Bull Creek upstream of Lanier Spring. All surface flow ended approximately 300 feet downstream.

On August 6th, 0.375 (3/8) pounds of eosine dye was poured into the main stem of Bull Creek about 980 feet upstream of Lanier Spring (Photos 3 and 4). Surface flow ended approximately 300 feet downstream of the injection area. Dye was poured in 1/3 doses about 5 hours apart, beginning at 0925 and ending at 2000.

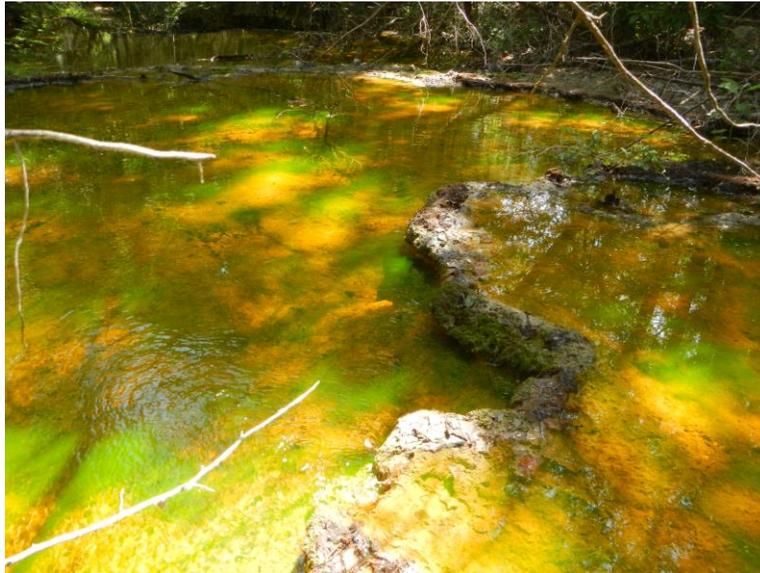
Photo 4. Eosine dye in Bull Creek about 300 feet downstream of the injection point near where all surface flow ended.
