HISTORIC STRUCTURE REPORT TRAVIS COUNTY PALM SCHOOL BUILDING

CONTRACT NO. 4400003304

APRIL 12, 2018

EXECUTIVE SUMMARY

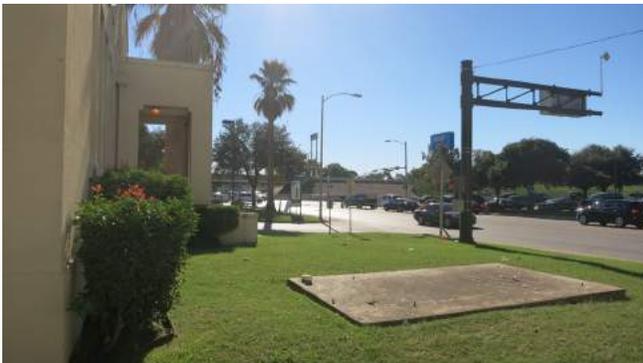
Concrete pad, remnant infrastructure - source unknown. Photo provided by DWG

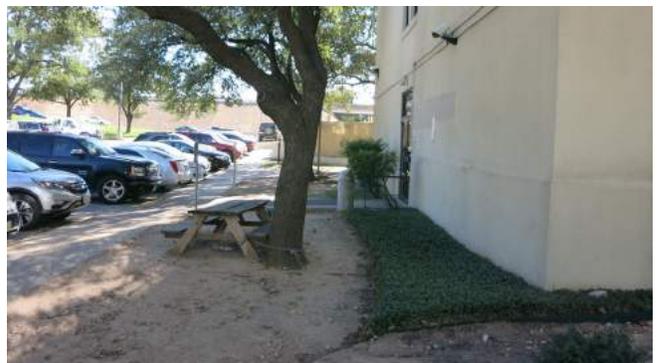
Empty planting bed and eroded lawn space on North side of building. Photo provided by DWG

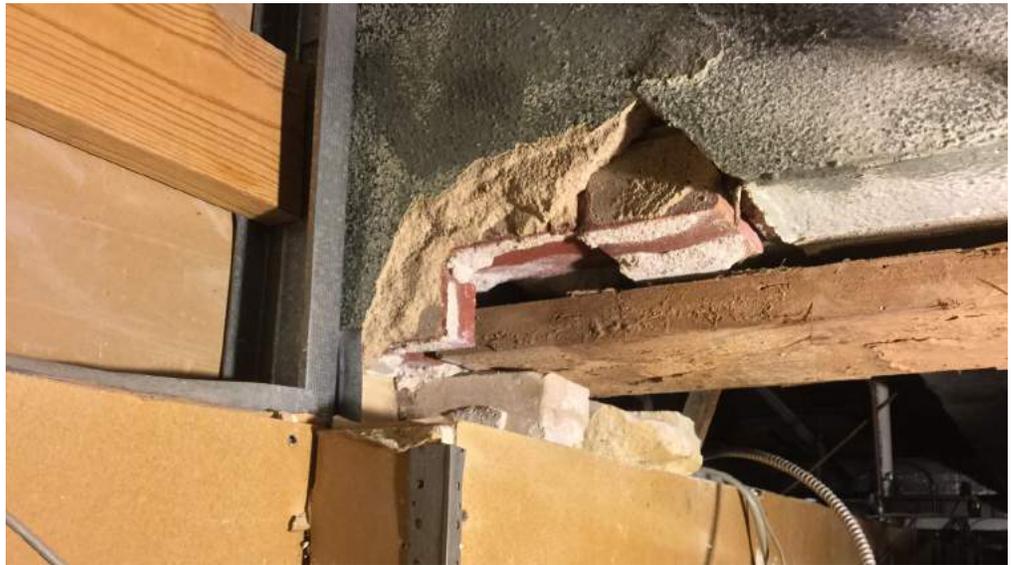
Interior finish repairs underway in room 2015 during our survey reveal that evidence of the locations of blackboards, baseboard, and finish patterns remain below contemporary finishes.

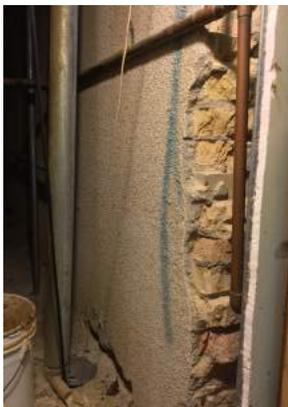
Original exterior wall of the 1936 Addition visible in a plumbing chase between the men’s and women’s restrooms added in 1948.

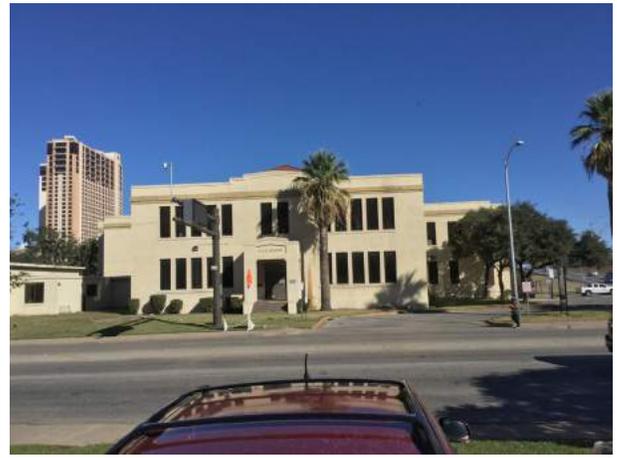
Palm School in 2017. The stucco was applied to the 1949 addition during a remodeling project done in 1980.

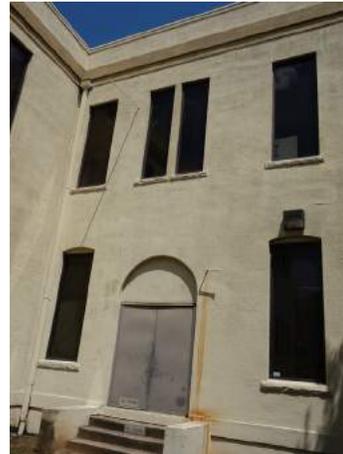
In 1980, the multi-lite window sash, doors and transoms were replaced with single lite sash and flush panel doors, which changed the pattern and texture of the building.

The original multi-lite wood window sash and frames on the 1892, 1910, 1924 and 1936 wings have been replaced with contemporary aluminum, single-lite windows, installed in the 1980 renovation project. The steel hopper windows on the 1949 wing have also been replaced with contemporary aluminum, single-lite windows. The historic masonry openings appear to be intact, which is significant. The historic wood and steel window sash were important, character defining features of the building, and gave it texture and scale that was lost with the installation of the single-lite windows. Although only limited architectural drawings were located for the 1949 wing of the building, many of the historic photographs that were located show the configuration of the window sash clearly. The historic photographs and original masonry openings are useful documentary tools to inform the restoration of the multi-lite window sash. Restoring the configuration of the windows to match the historic windows would return to a character defining feature and improve the appearance of the building.

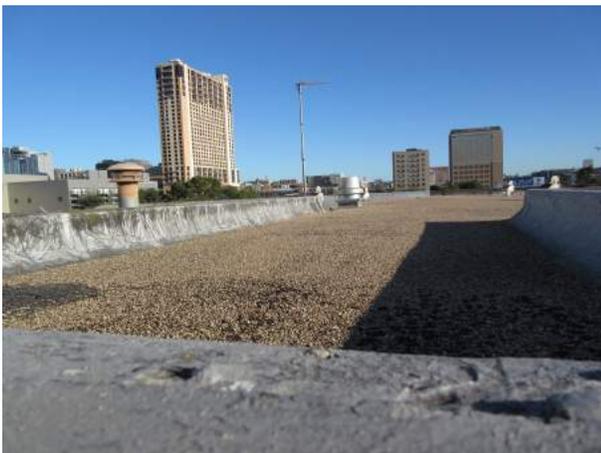
The roofs over the 1936 and 1949 additions are built-up asphaltic roofs with gravel topping.

The membrane roofing is aging and brittle, and the particulate coating is breaking down, allowing for accelerated weathering and brittling. The roofing membranes are nearing the end of their service life and should be replaced, to guard against roof leaks.

The roofs over the 1936 and 1949 wings are built-up asphalt with gravel topping, a more contemporary roofing material. The roof surfaces show signs of ponding in spots and should be further investigated, to identify areas of deterioration, bubbles or delamination of asphaltic membrane layers and refurbished or replaced as required. The 1936 wing roof is also enclosed with a masonry parapet, and does not appear to have a secondary drainage system, as required by current code, and secondary roof drains should be considered for this wing, as well.

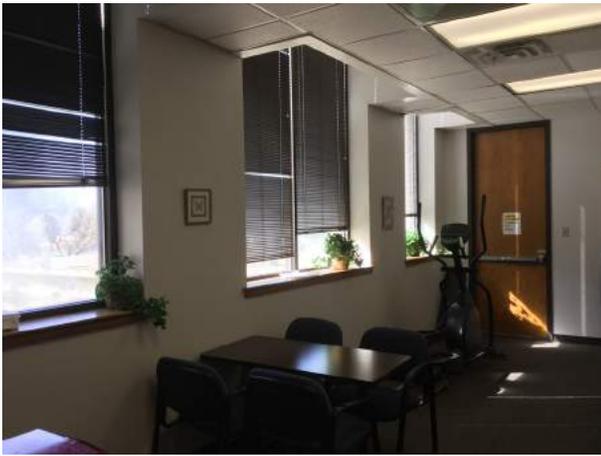
In the 1980 remodeling, suspended acoustical ceilings were installed, often below the heads of the windows.

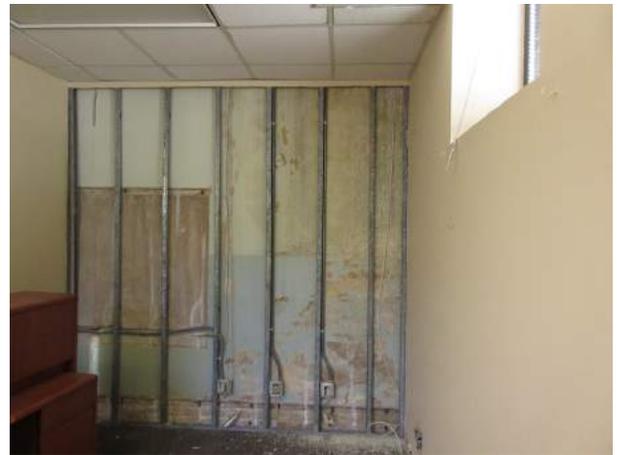
Behind the contemporary wall furring, there is a wealth of information about the wall trims, chalkboard locations and paint colors used in the classrooms.

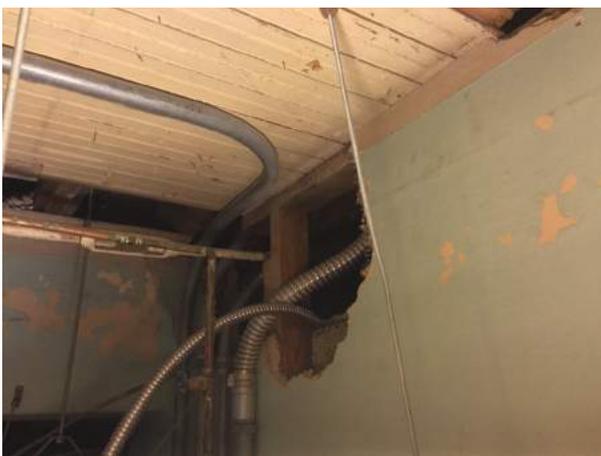
Detail view of an above ceiling condition, showing a beaded board ceiling, ghost of ceiling moulding and paint colors.

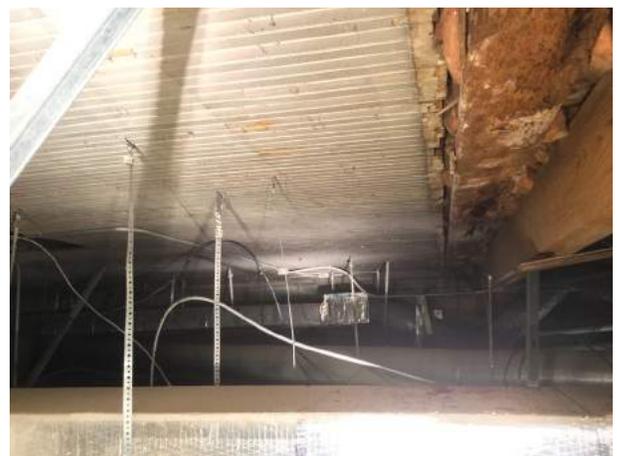
Detail view of an above ceiling condition, showing a beaded board ceiling and an early steel beam, installed where a wall was removed.

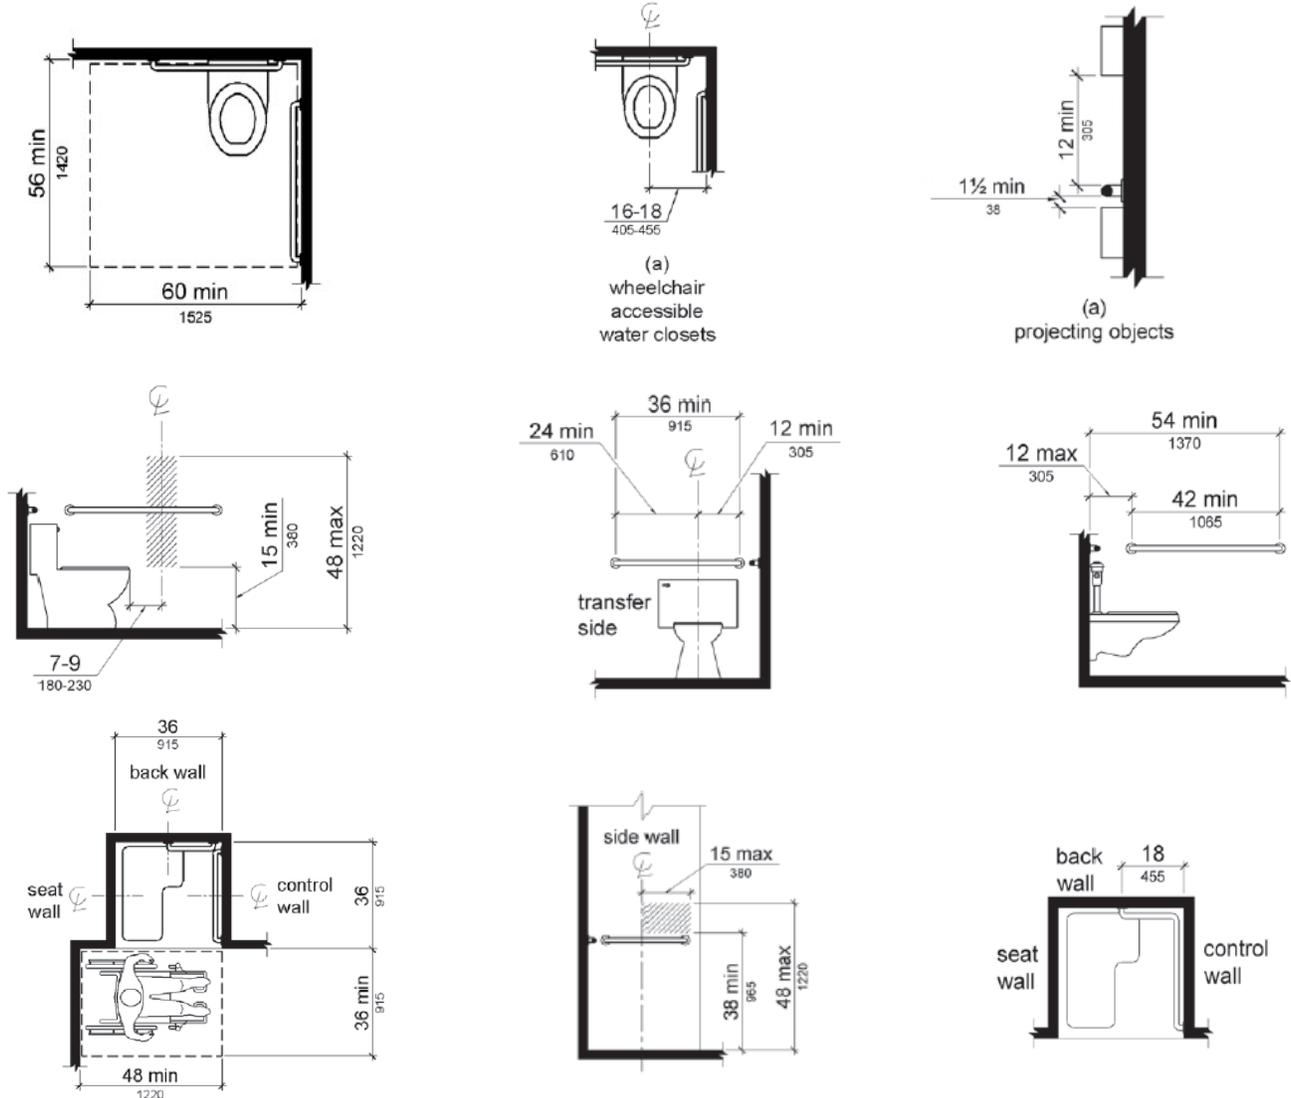
The width of the maneuvering clearance to exit the restroom is 36", 48" minimum required. TAS 404.2.4

Paper towel dispenser is a protruding object in the circulation space of the restroom. TAS 307.2

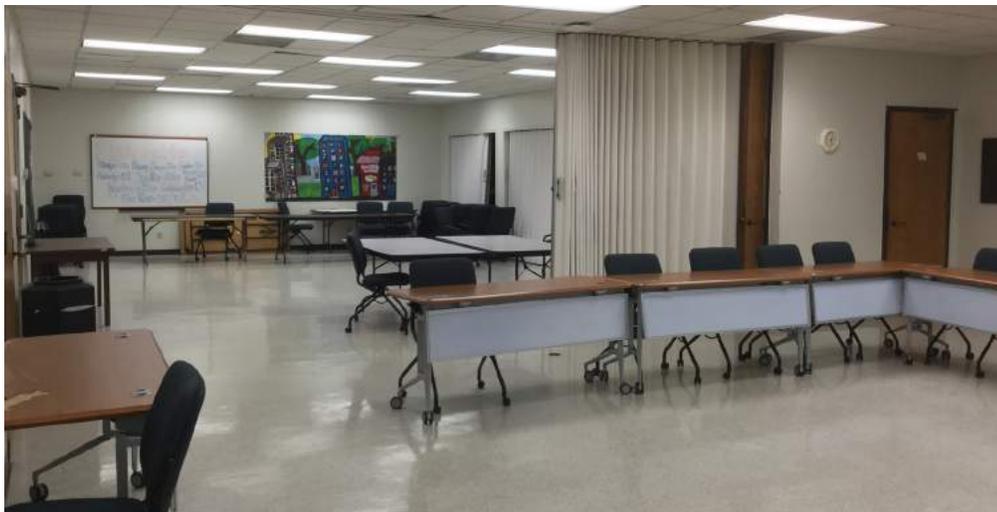
Room 2307 / 2309 exceeds the Code defined maximum of 750 SF for a room to be considered accessory to a Business Use. It is therefore classified as Assembly A-3.

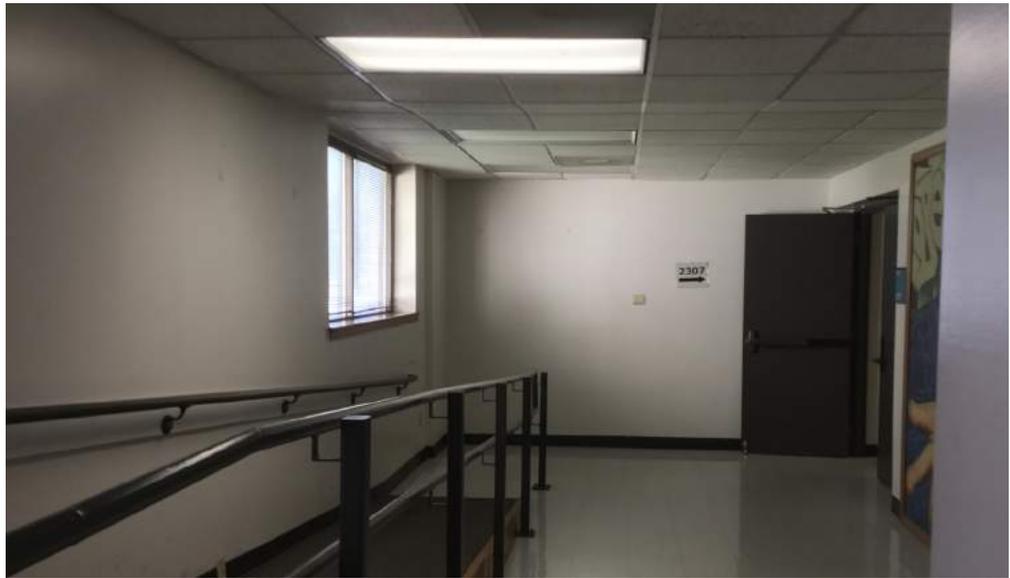
The door from this corridor to the 1949 Addition has a fire-resistance rating of three hours. This fire door assembly and the masonry construction allow the 1949 Addition to be considered as a Separate Building from the rest of the Facility.

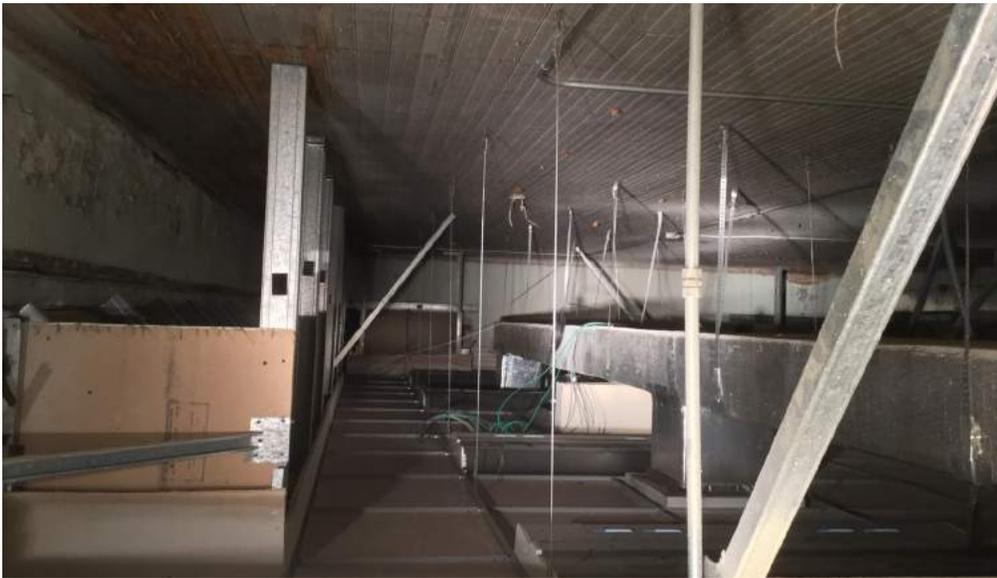
The portions of the building constructed in 1890, 1910, 1924, and 1949 have been determined to be best defined as construction Type IIIB. The distinguishing characteristic of the Palm School Building contributing to this is the load bearing masonry used for the exterior walls throughout the facility. Within this portion of the facility the IIIB designation is selected as there is no protection of combustible framing (0 Hours of Fire-Resistance) within the interior building elements.

Space above the suspended ceiling in the third floor of the 1910 Addition shows that there is unprotected combustible material used for the interior framing. Construction Type IIIB applies as the exterior masonry walls are non-combustible, and this interior framing is unprotected.

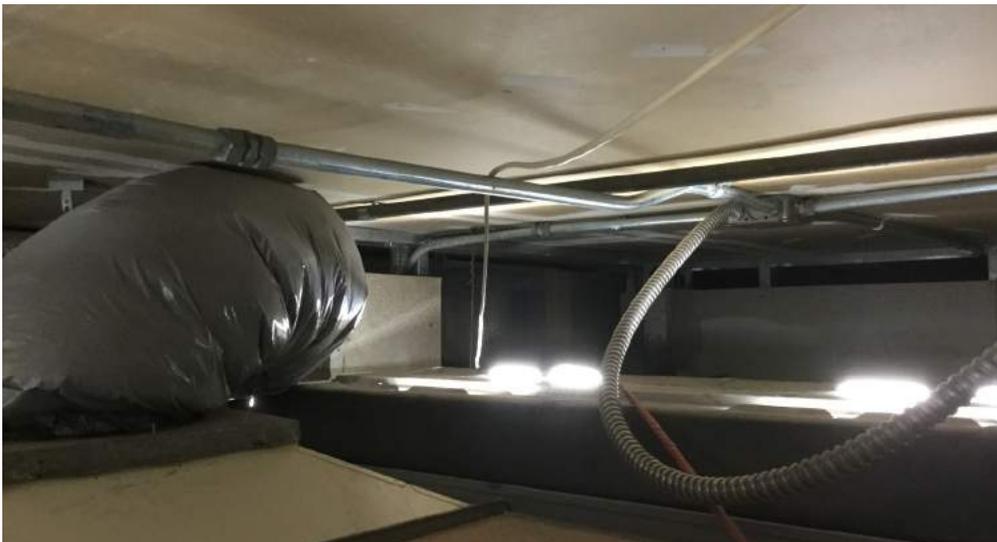
The 1936 addition on the north side of the facility does approach achieving a construction Type IIIA due to efforts, most likely associated with the Delgado Plans, to protect structural steel components with layers of "Type X" gypsum board. However, building code revisions since this protection's installation now require a more enhanced level of protection for horizontal assemblies, such as floors and above ceilings than the Type X product in place provides. Therefore the lesser construction Type IIIB must be used.

Space above an office ceiling on the first floor of the 1936 Addition shows that gypsum board has been installed to provide improved fire resistance.

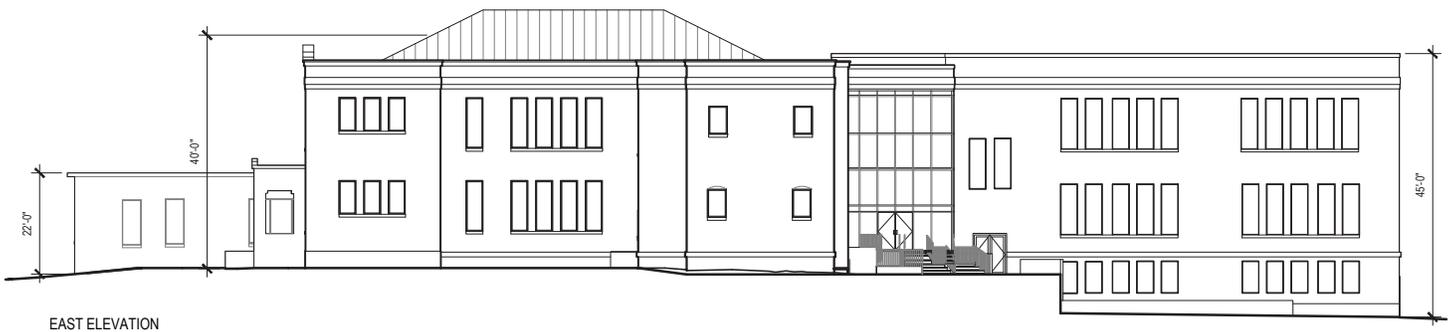
Exterior elevation graphic showing described building heights. Graphic not to scale.

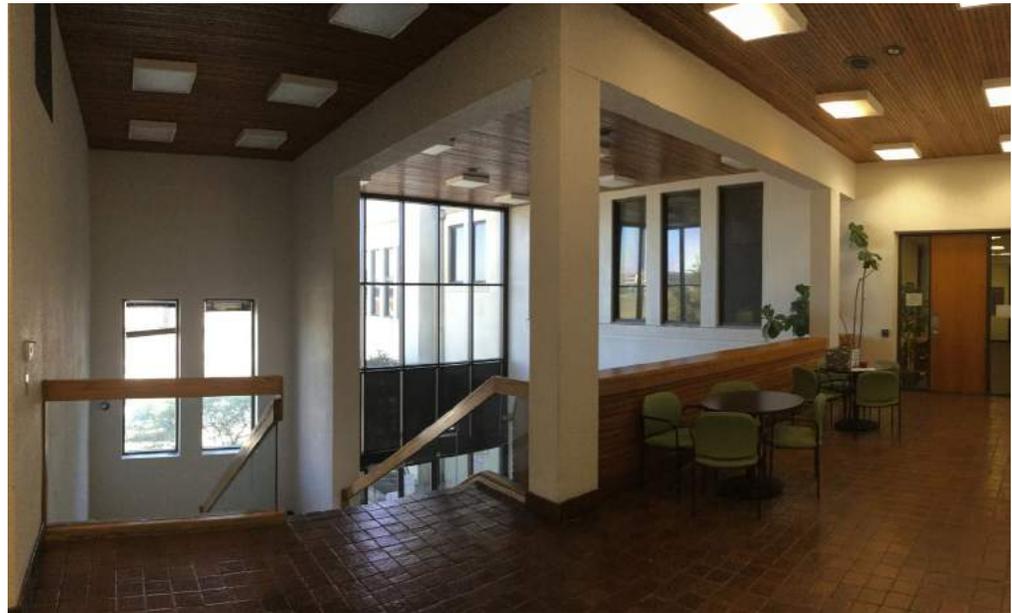
View of the Atrium from the third floor looking toward the north façade of the original 1892 building.

The atrium introduced in the 1980 renovation provides a common area for entry, security and necessary vertical accessibility. However by today's standards, the atrium falls far short of current building code requirements defined in Section 404:

Violation: There is no sprinkler system installed in any part of the Palm School Building

Violation: There is no smoke control system installed in the atrium. Note that Section 404.7 requiring the standby power for the smoke control system is also in violation.

Violation: The fact that large historic window openings face the atrium and are not sprinkler-protected is a major concern. Another concern is that the doors to both the first floor mechanical room and office spaces are louvered at the atrium, which is prohibited by code.

- **Fire Suppression and Smoke Control:** The presence of the Atrium alone requires that an automatic sprinkler system be installed throughout this facility and that it be monitored by an Automatic Fire Alarm with notification capability. A smoke control system also needs to be installed in the Atrium. These are the most important ways to improve life safety for the occupants. The cultural significance of this Historic Landmark also warrants this degree of protection.
- **Means of Egress:** Getting occupants out of the building safely in an emergency is vital. Correcting noted violations with regard to stairs, ramps, ramp slope, handrails, guards / barriers, fire-resistance labeled door assemblies and Exit stair enclosures will all be necessary to comply with the current Building Code.

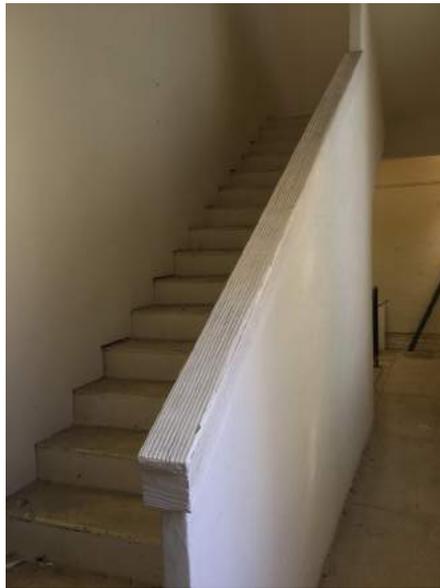
Violation: East Stair from the first floor to the third lacks nosings, but may be exempt as it could be considered to be a historic stair.

The East Stair lacks a Code compliant nosing profile, graspable handrails, egress lighting, and one hour fire-resistant Exit Access Stairway enclosure.

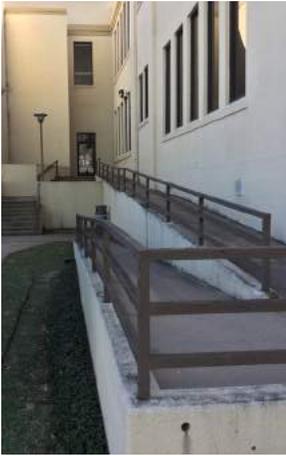
Violation: As documented in the Accessibility narrative, the two outdoor ramps converging on the west side of the facility and the indoor ramp to the 1949 Addition lack proper landings at changes in direction.

Violation: A height of 78" (6'-6") was observed along the interior Corridor with Ramp to the 1949 Addition.

The ramp to the 1949 Addition lacks Code compliant headroom, slope, and landing size for a change in direction.
